EXISTING TARLAC STATE UNIVERSITY HOTEL PERSPECTIVE

PROJECT TITLE: REPAIR AND RE-PAINTING OF TSU HOTEL	REQUESTING OFFICE:  MR. VON REX M. REYES MANAGER, TSU HOTEL	PREPARED BY:  MR. WENCIE S. MANABOG DRAFTSMAN, FDMO	CERTIFIED BY:  AR. ARLEN M. GUIEB DIC DIRECTOR, FDMO	RECOMMENDING APPROVAL:  DR. GRACE N. ROSETE VP, ADMINISTRATION AND FINANCE	APPROVED:  DR. ARNOLD E. VELASCO PRESIDENT	SHEET CONTENTS: AS SHOWN DATE: NOVEMBER, 2023	SHEET NO.: A-2 PAGE NO.: 02/19
PROJECT LOCATION: LUCINDA EXTENSION CAMPUS, TARLAC STATE UNIVERSITY

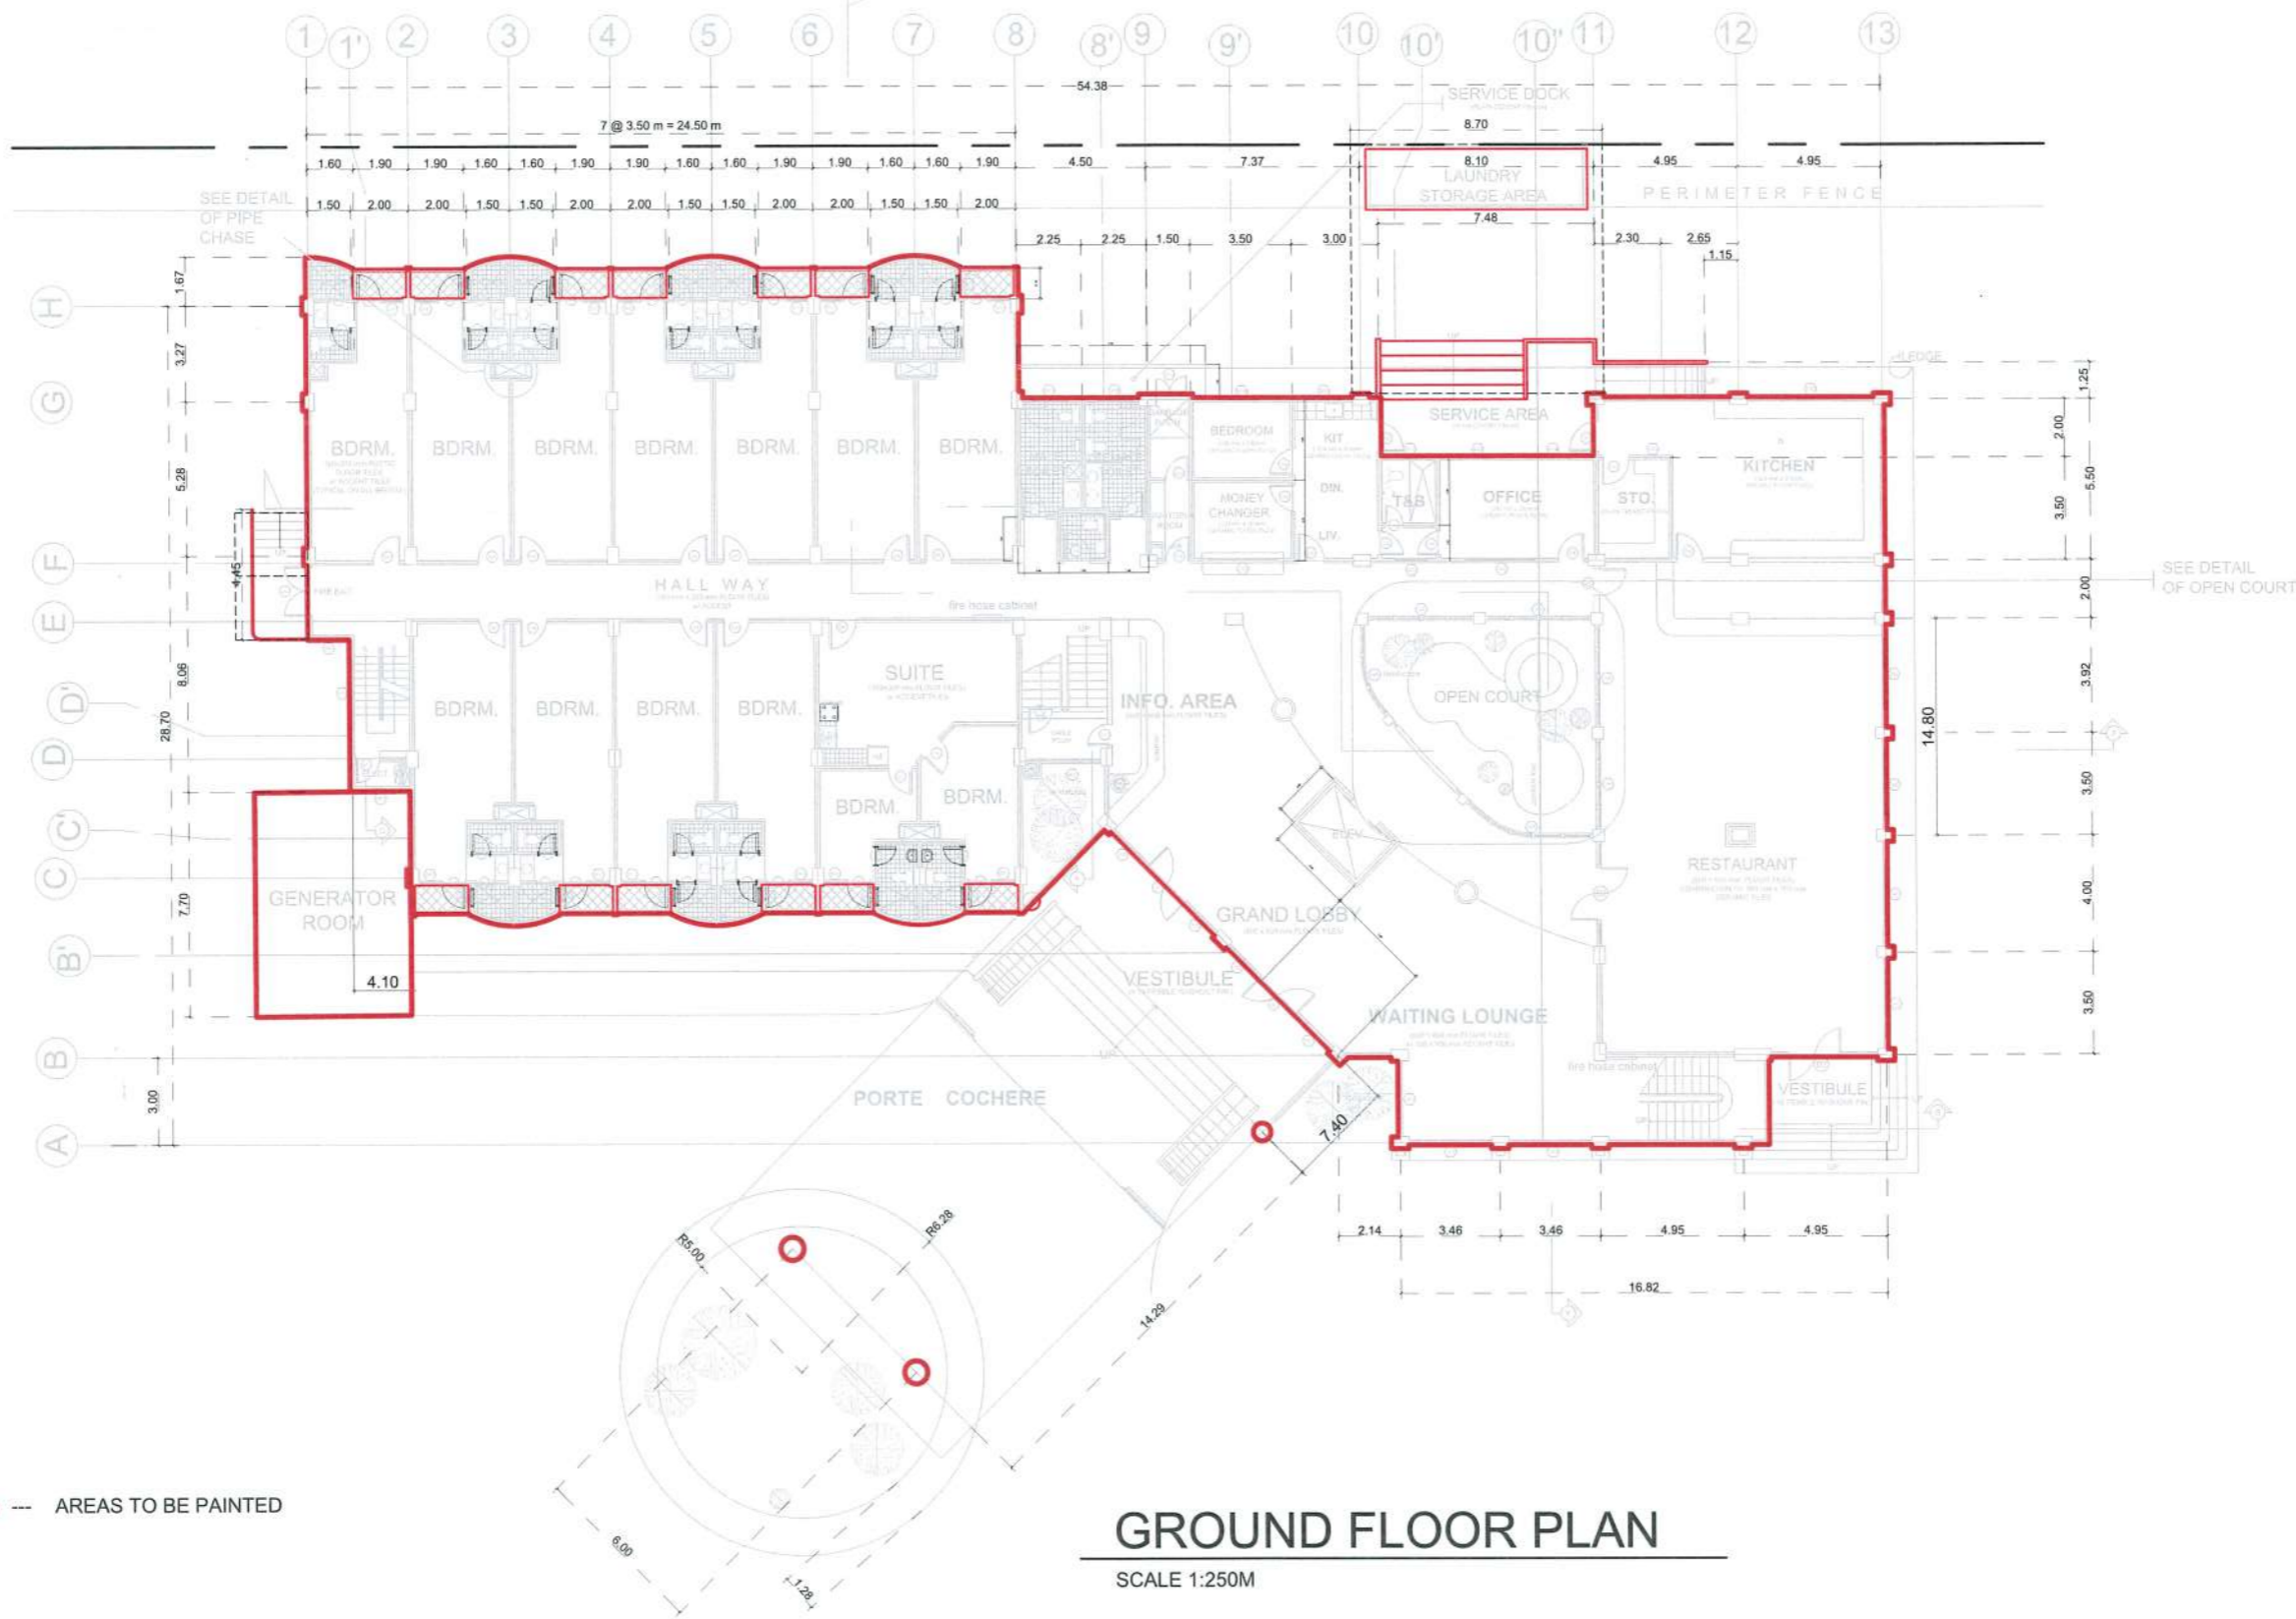
### GROUND FLOOR PLAN

--- AREAS TO BE PAINTED

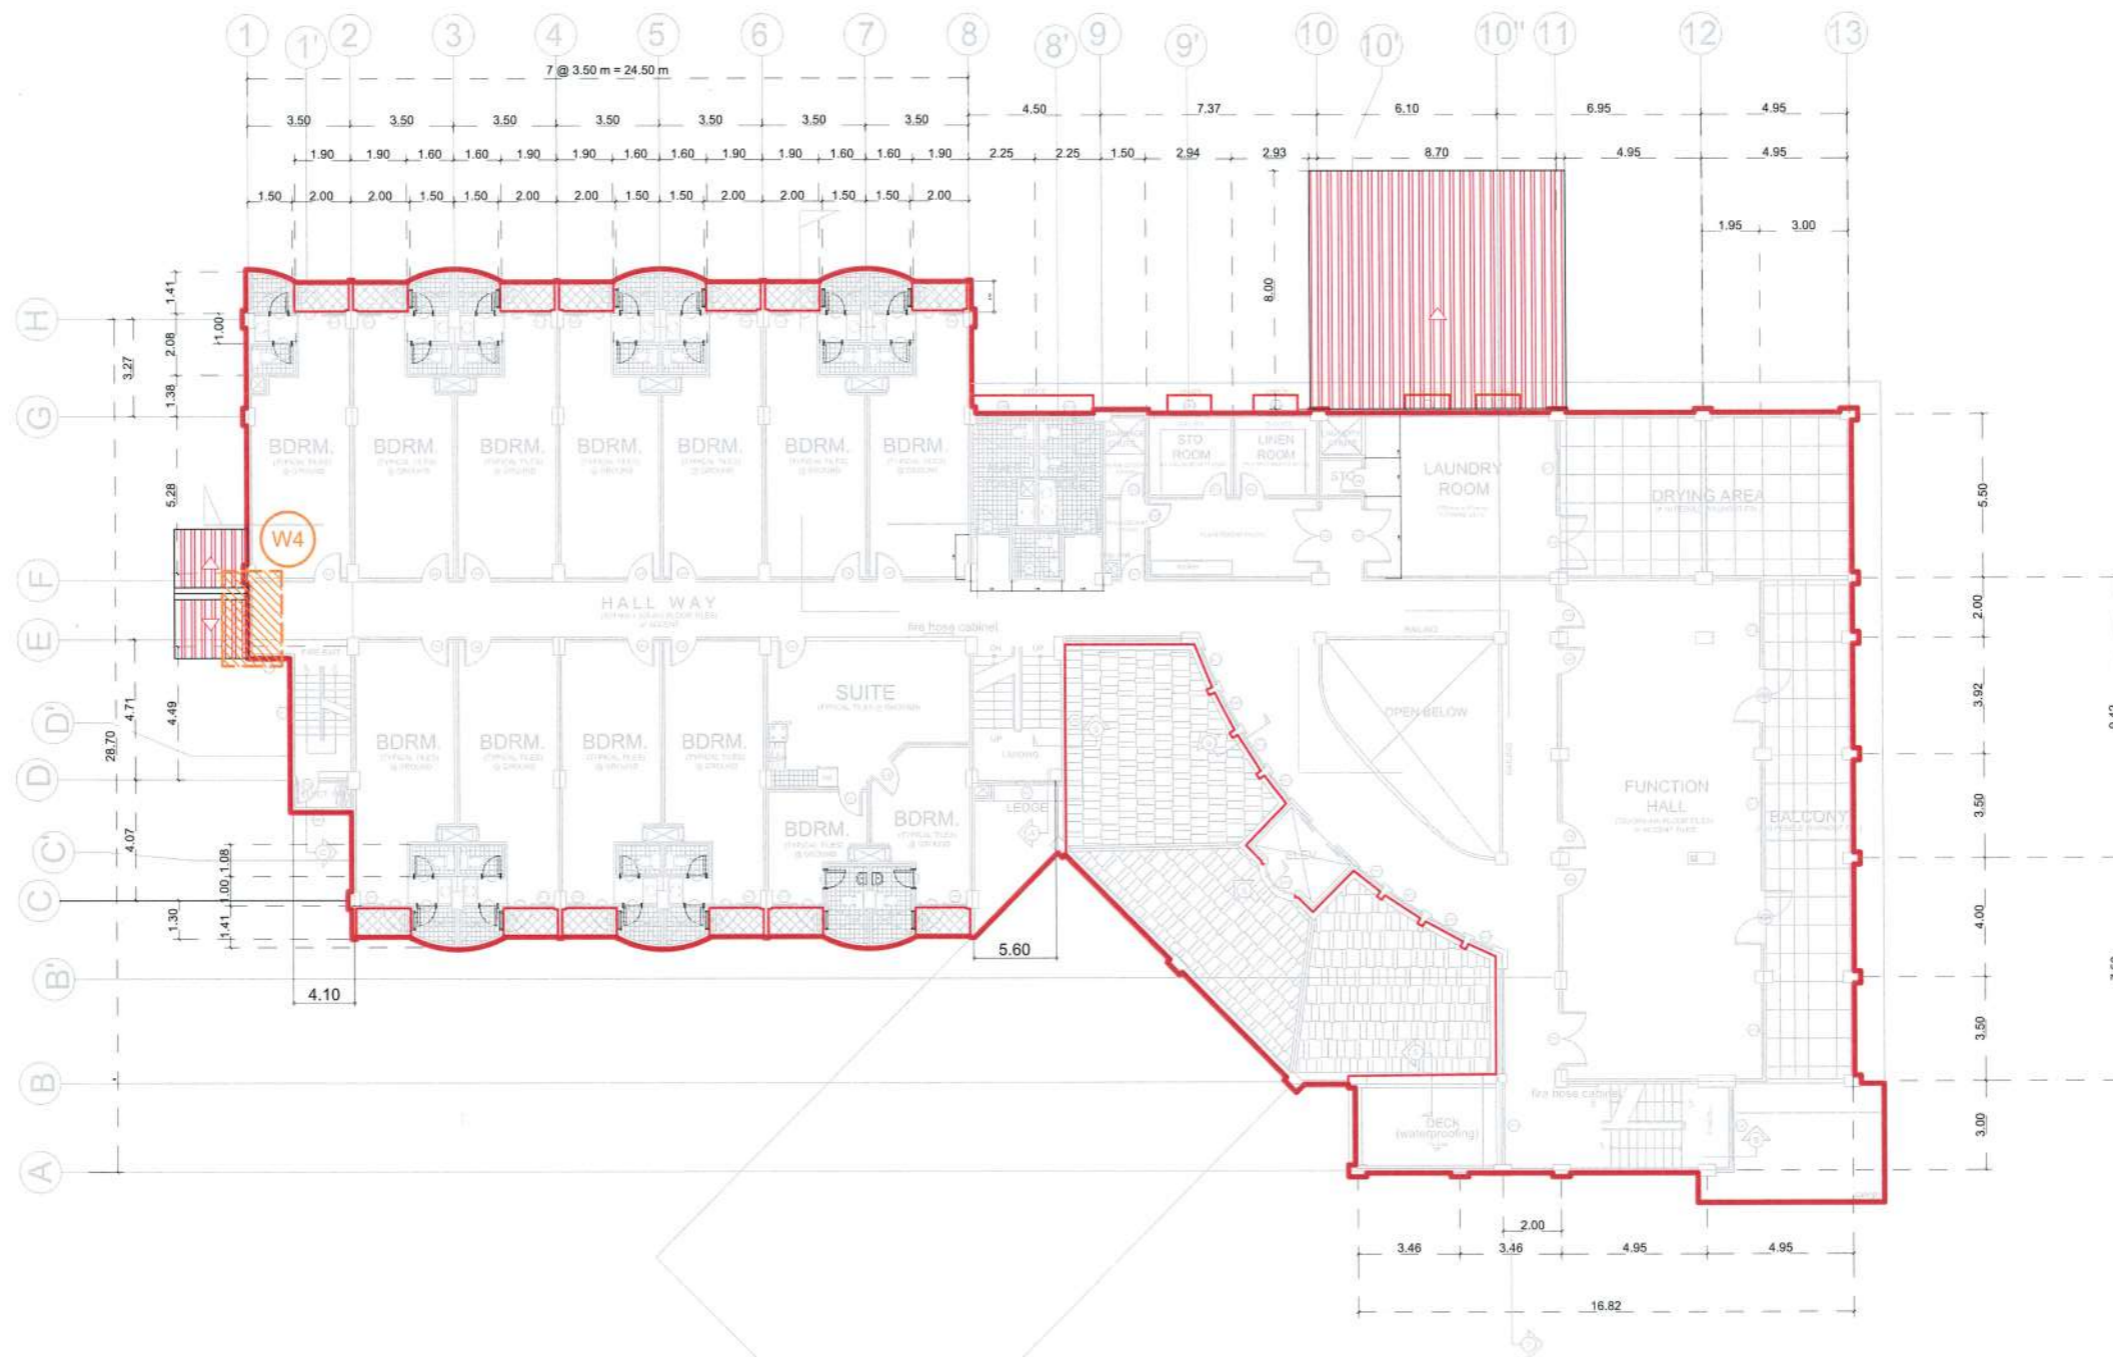
**SECOND FLOOR PLAN**

- AREAS TO BE PAINTED
- WINDOWS TO BE REPAIR  
(SEE SCHEDULE OF WINDOWS)

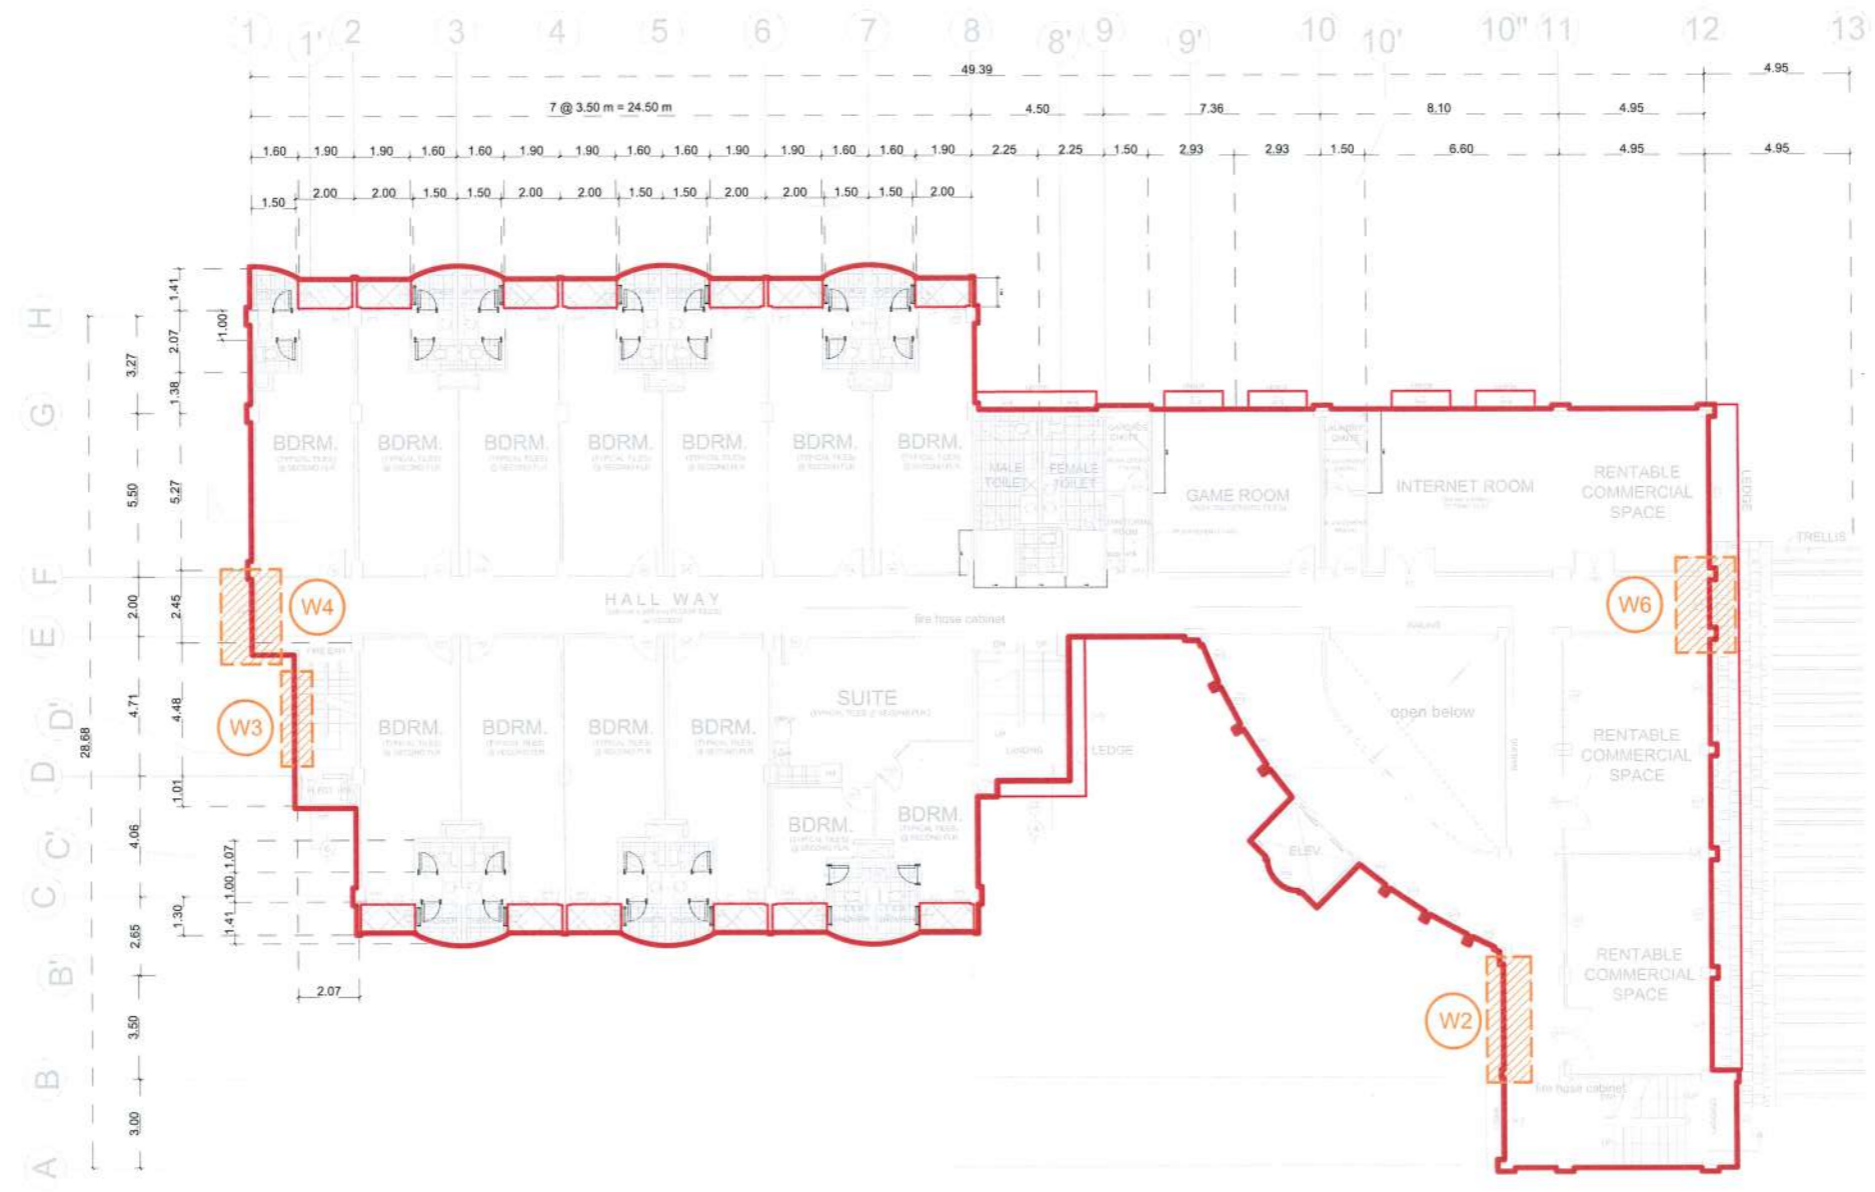
**THIRD FLOOR PLAN**

- AREAS TO BE PAINTED
- WINDOWS TO BE REPAIR (SEE SCHEDULE OF WINDOWS)

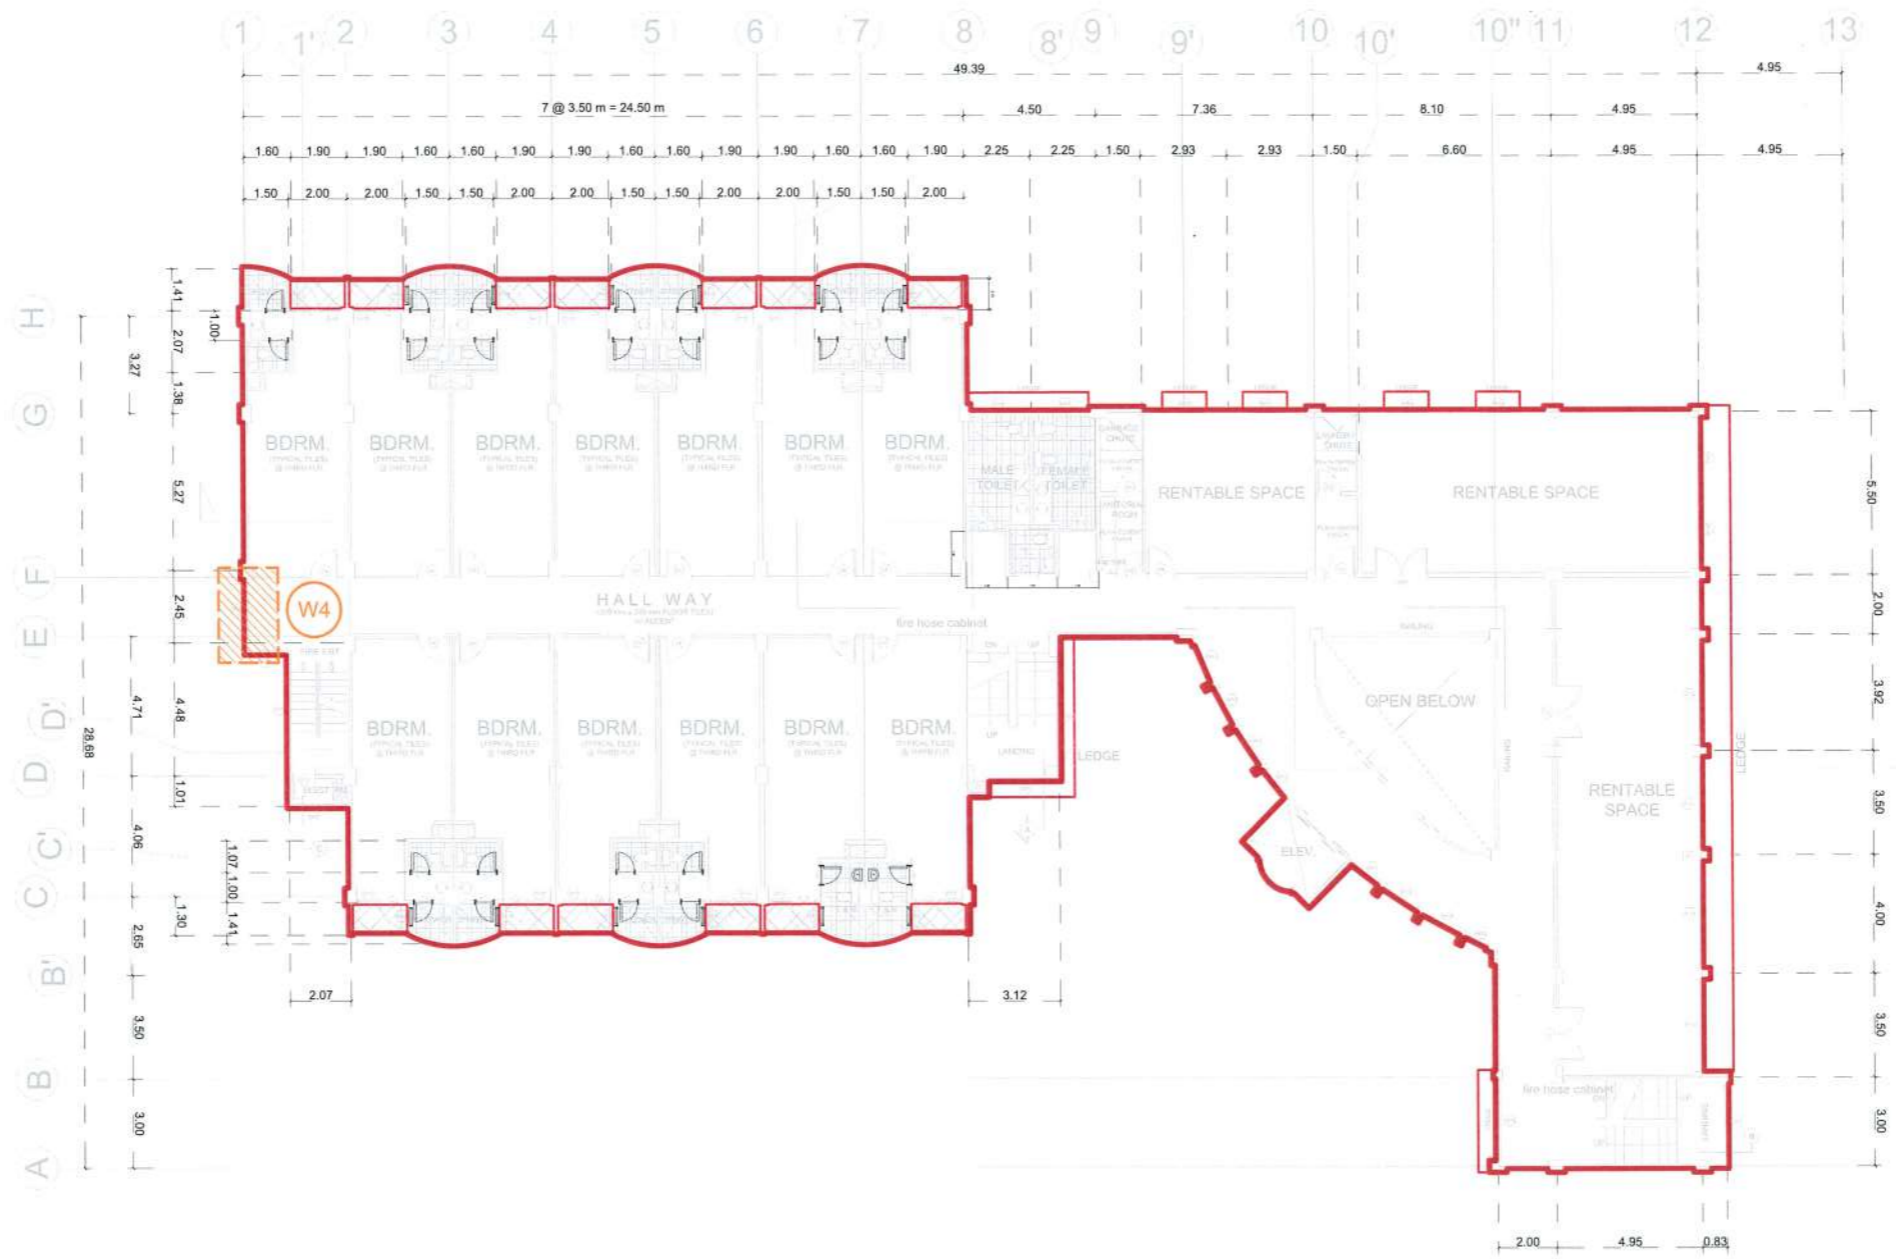
**FOURTH FLOOR PLAN**

- AREAS TO BE PAINTED
- WINDOWS TO BE REPAIR (SEE SCHEDULE OF WINDOWS)

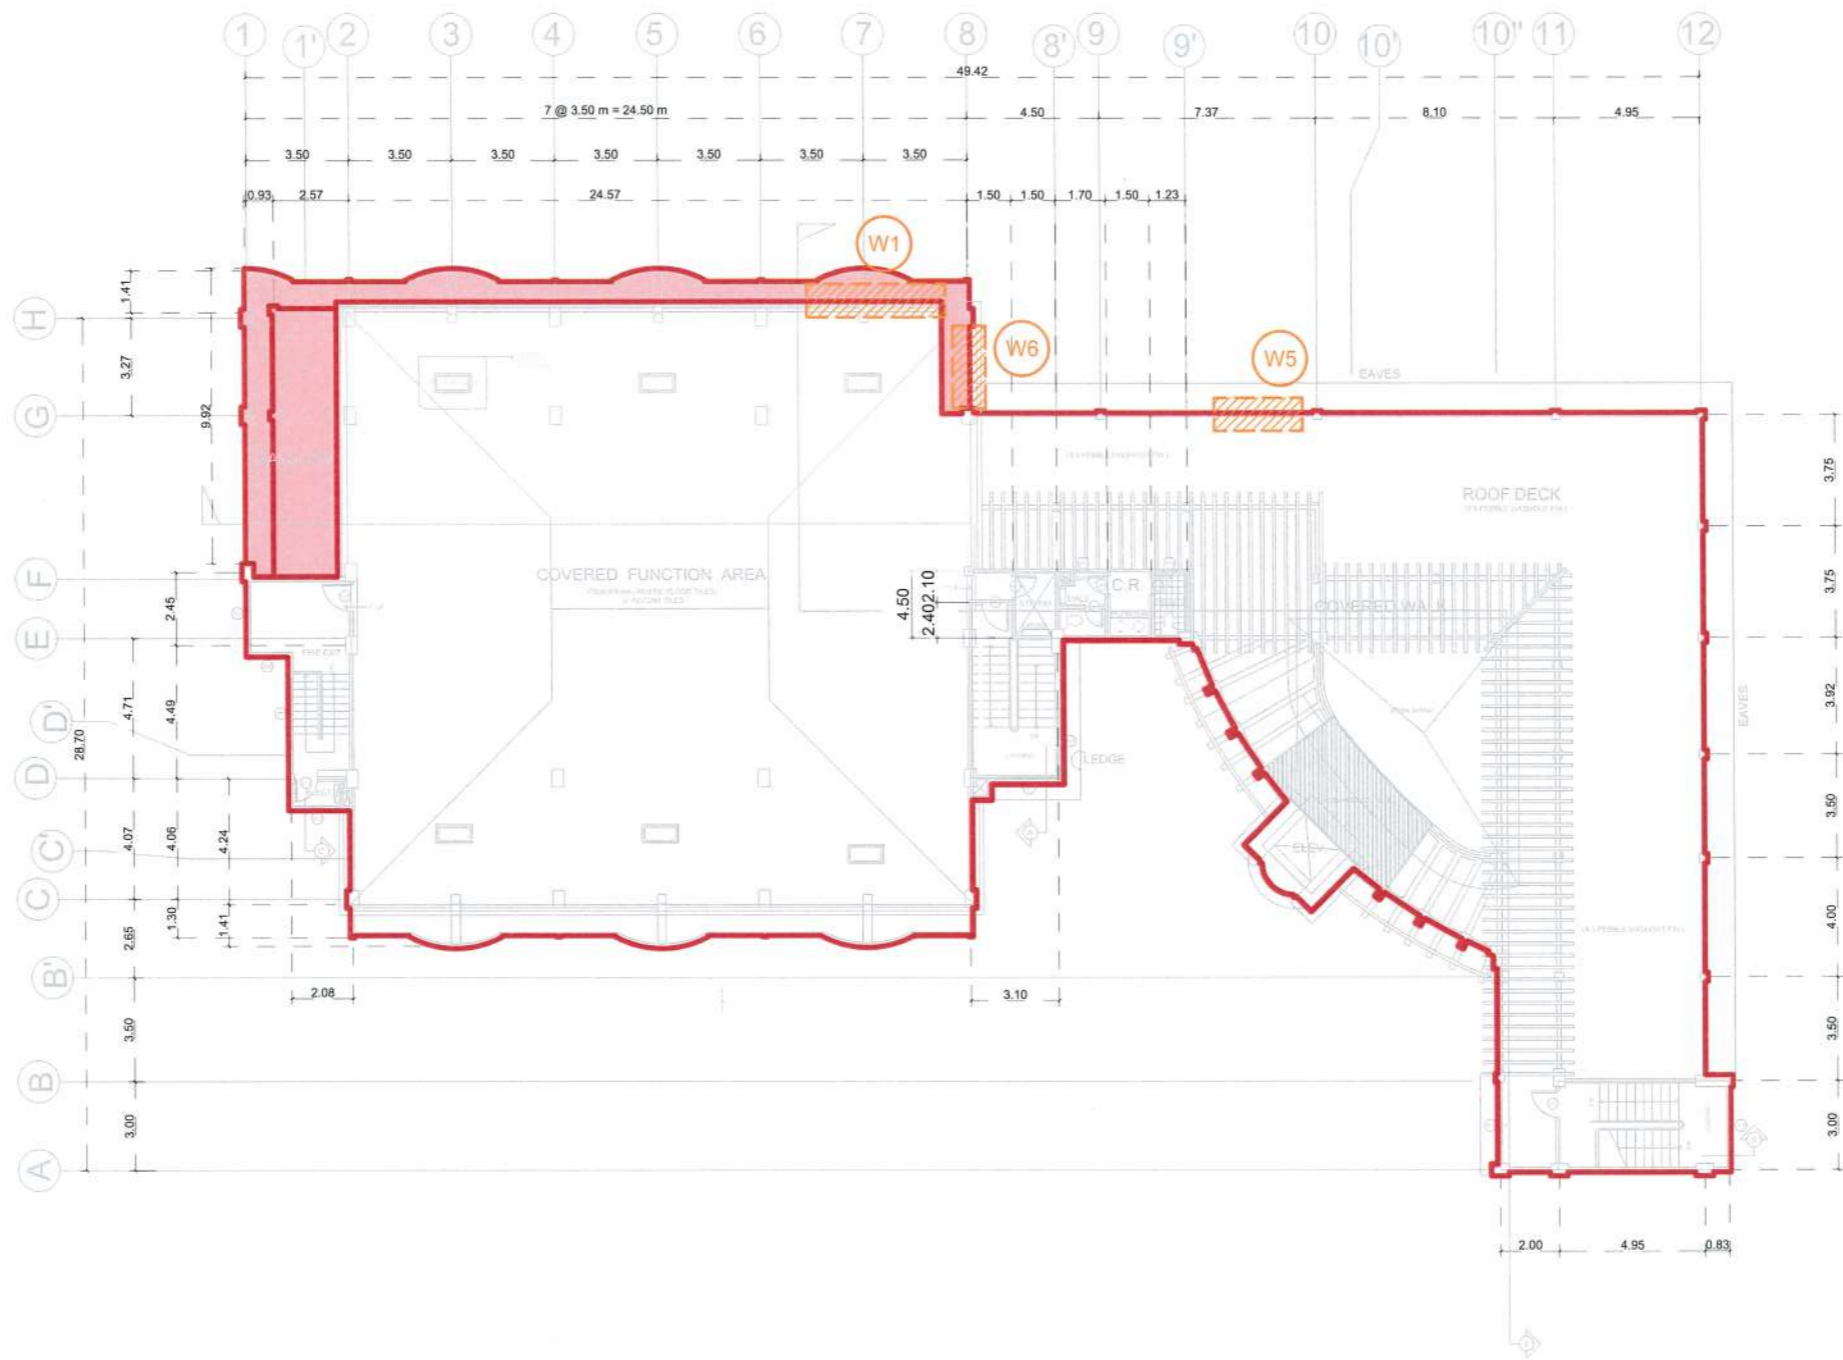
**ROOF DECK FLOOR PLAN**

AREAS TO BE PAINTED
-

WINDOWS TO BE REPAIR  
(SEE SCHEDULE OF WINDOWS)
-

AREA FOR APPLICATION OF 5 COATS  
OF CEMENTITIOUS WATERPROOFING

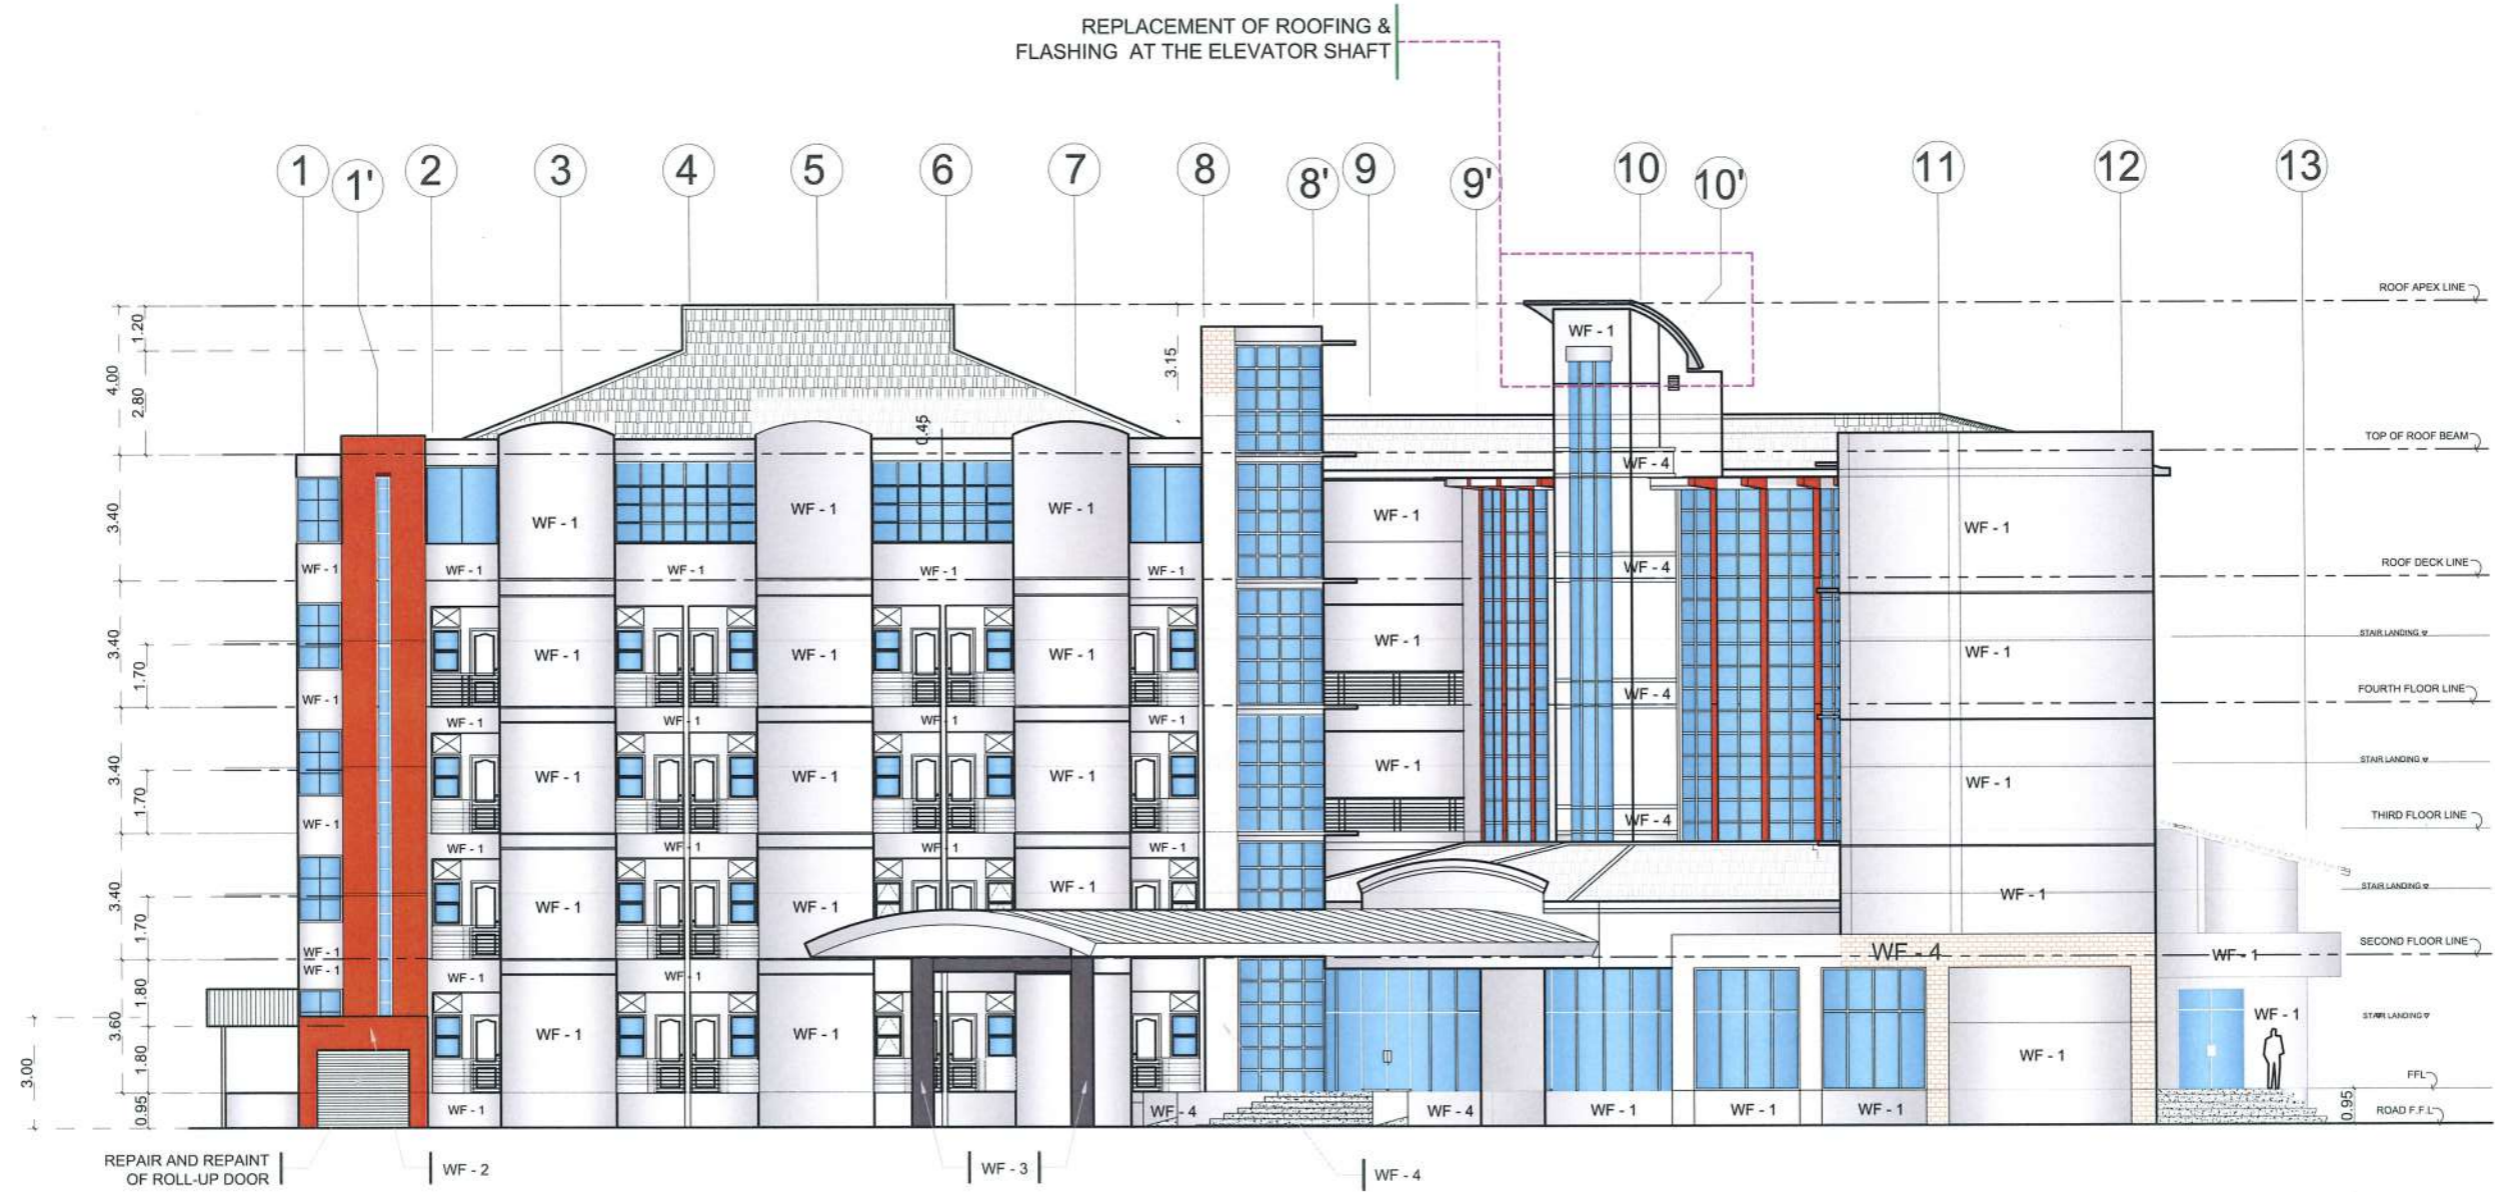
**TSU HOTEL FRONT ELEVATION**

1. SURFACE PREPARATION IS A MUST.
2. REPAIR & RE-PAINING OF ALL WINDOW FRAMES USING ENAMEL PAINT (INTERIOR & EXTERIOR SIDE).
3. REPAIR & RE-PAINING OF ALL AIR-CONDITION UNIT FRAMING USING ENAMEL PAINT.
4. APPLICATION OF SKIMCOAT/ BODY FILLER PRIOR TO TOPPING OF PRIMER AND TOPCOATS OF PAINT.
5. TYPE OF PAINT TO BE USED MUST BE APPROVED BY THE PROJECT IN-CHARGE.

SCRAPPING OF OLD PAINT, SURFACE PREPARATION, PRIMER, OFF-WHITE SEMI-GLOSS LATEX PAINT
WF - 2

SCRAPPING OF OLD PAINT, SURFACE PREPARATION, PRIMER, TERACOTTA RED SEMI-GLOSS LATEX PAINT
WF - 3

SCRAPPING OF OLD PAINT, SURFACE PREPARATION, PRIMER, GRAY SEMI-GLOSS LATEX PAINT
WF - 4

SURFACE PREPARATION, APPLICATION OF SANDED GROUT AND TOP WITH ACRYLIC EMULSION

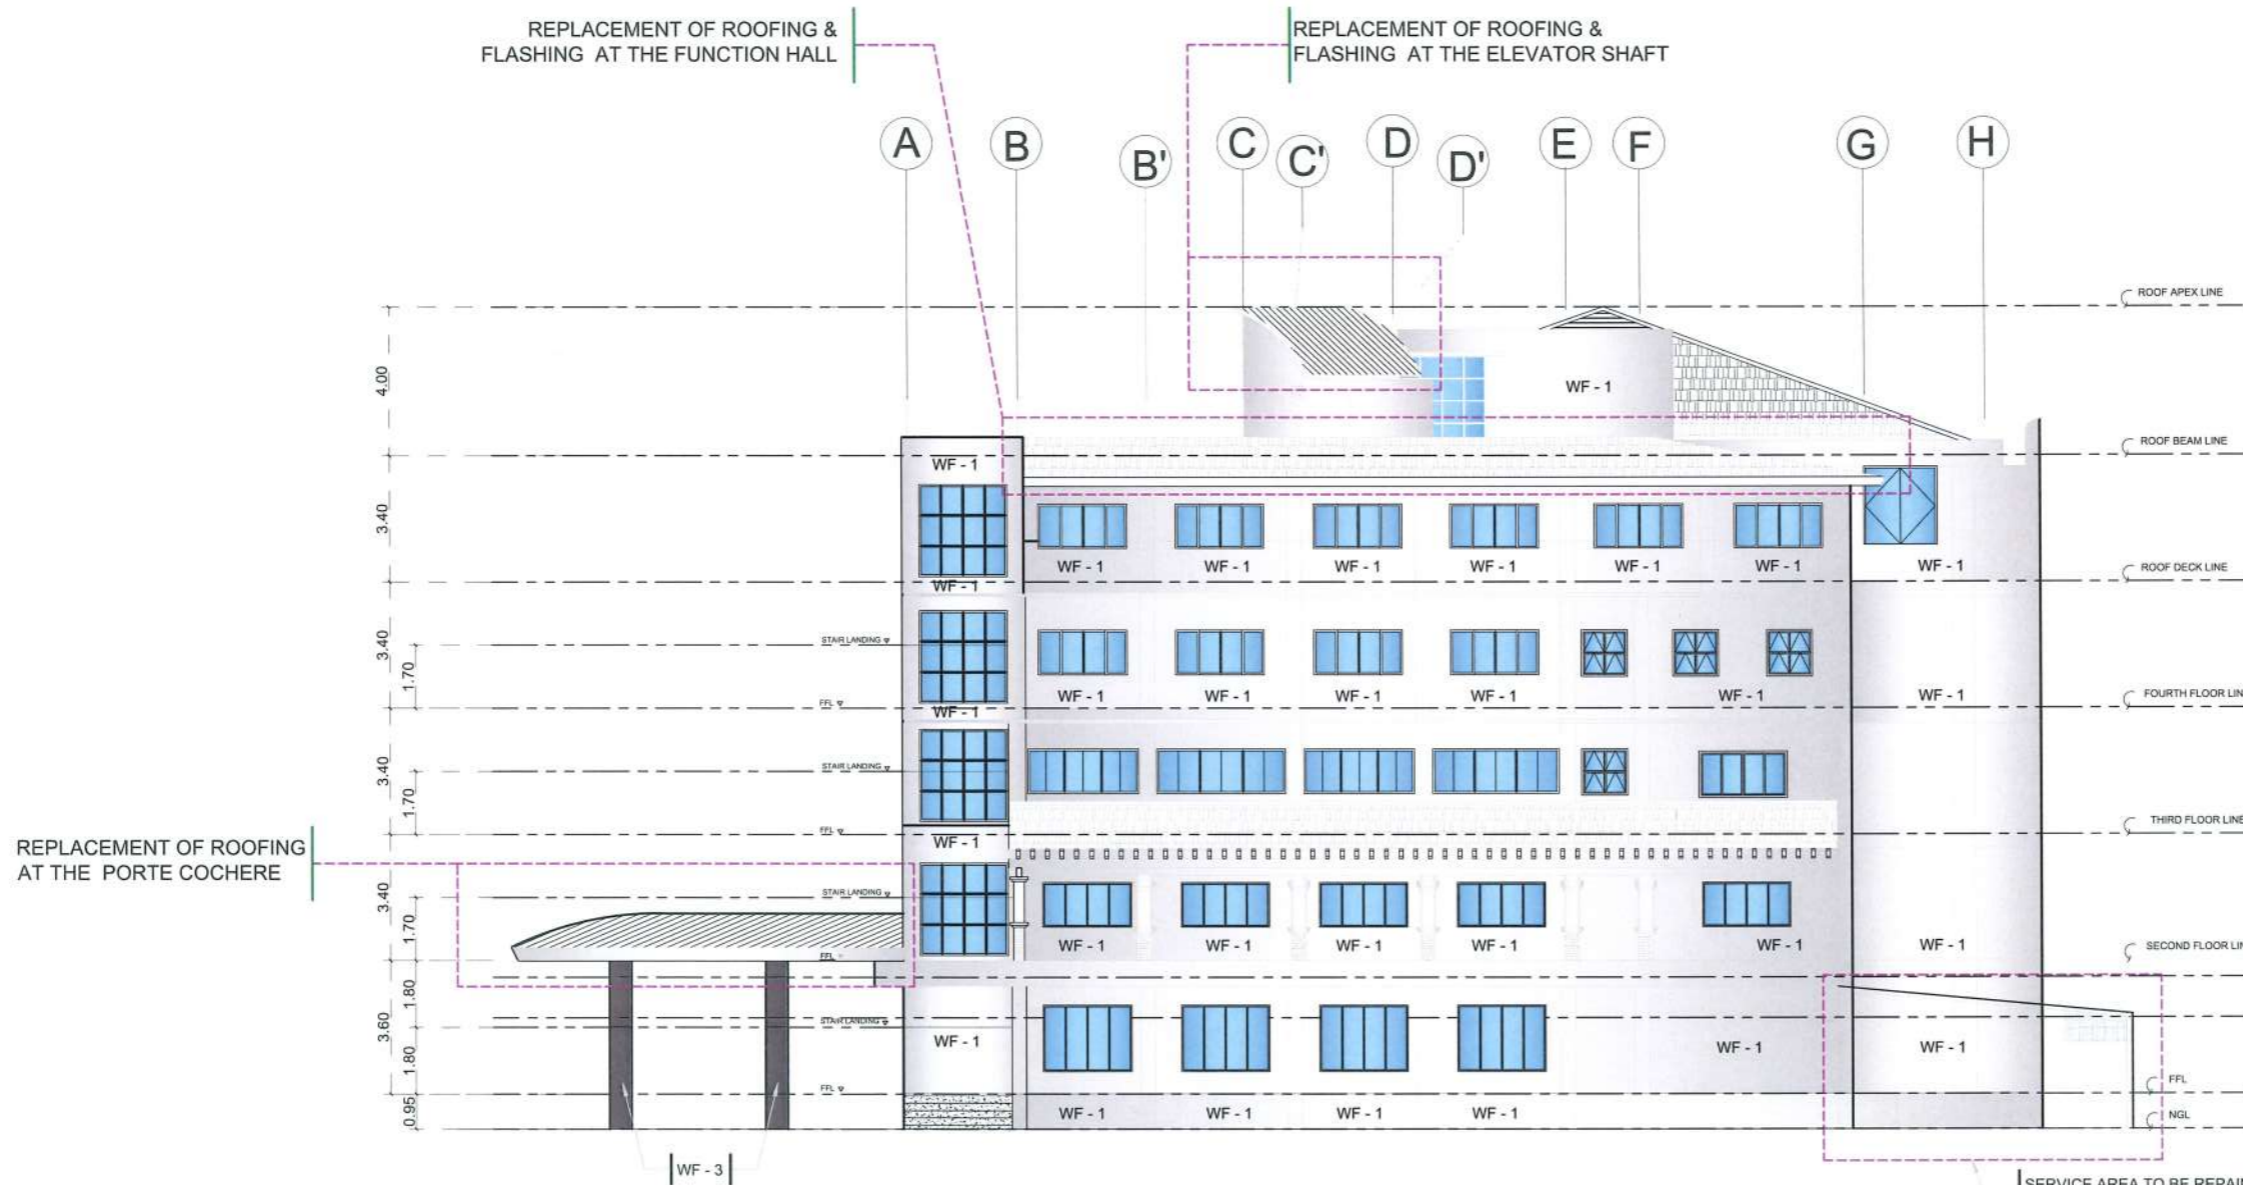
**TSU HOTEL RIGHT SIDE ELEVATION**

1. SURFACE PREPARATION IS A MUST.
2. REPAIR & RE-PAINTING OF ALL WINDOW FRAMES USING ENAMEL PAINT (INTERIOR & EXTERIOR SIDE).
3. REPAIR & RE-PAINTING OF ALL AIR-CONDITION UNIT FRAMING USING ENAMEL PAINT.
4. APPLICATION OF SKIMCOAT/ BODY FILLER PRIOR TO TOPPING OF PRIMER AND TOPCOATS OF PAINT.
5. TYPE OF PAINT TO BE USED MUST BE APPROVED BY THE PROJECT IN-CHARGE.

SCRAPPING OF OLD PAINT, SURFACE PREPARATION, PRIMER, OFF-WHITE SEMI-GLOSS LATEX PAINT
WF - 2

SURFACE PREPARATION, APPLICATION OF SANDED GROUT AND TOP WITH ACRYLIC EMULSION

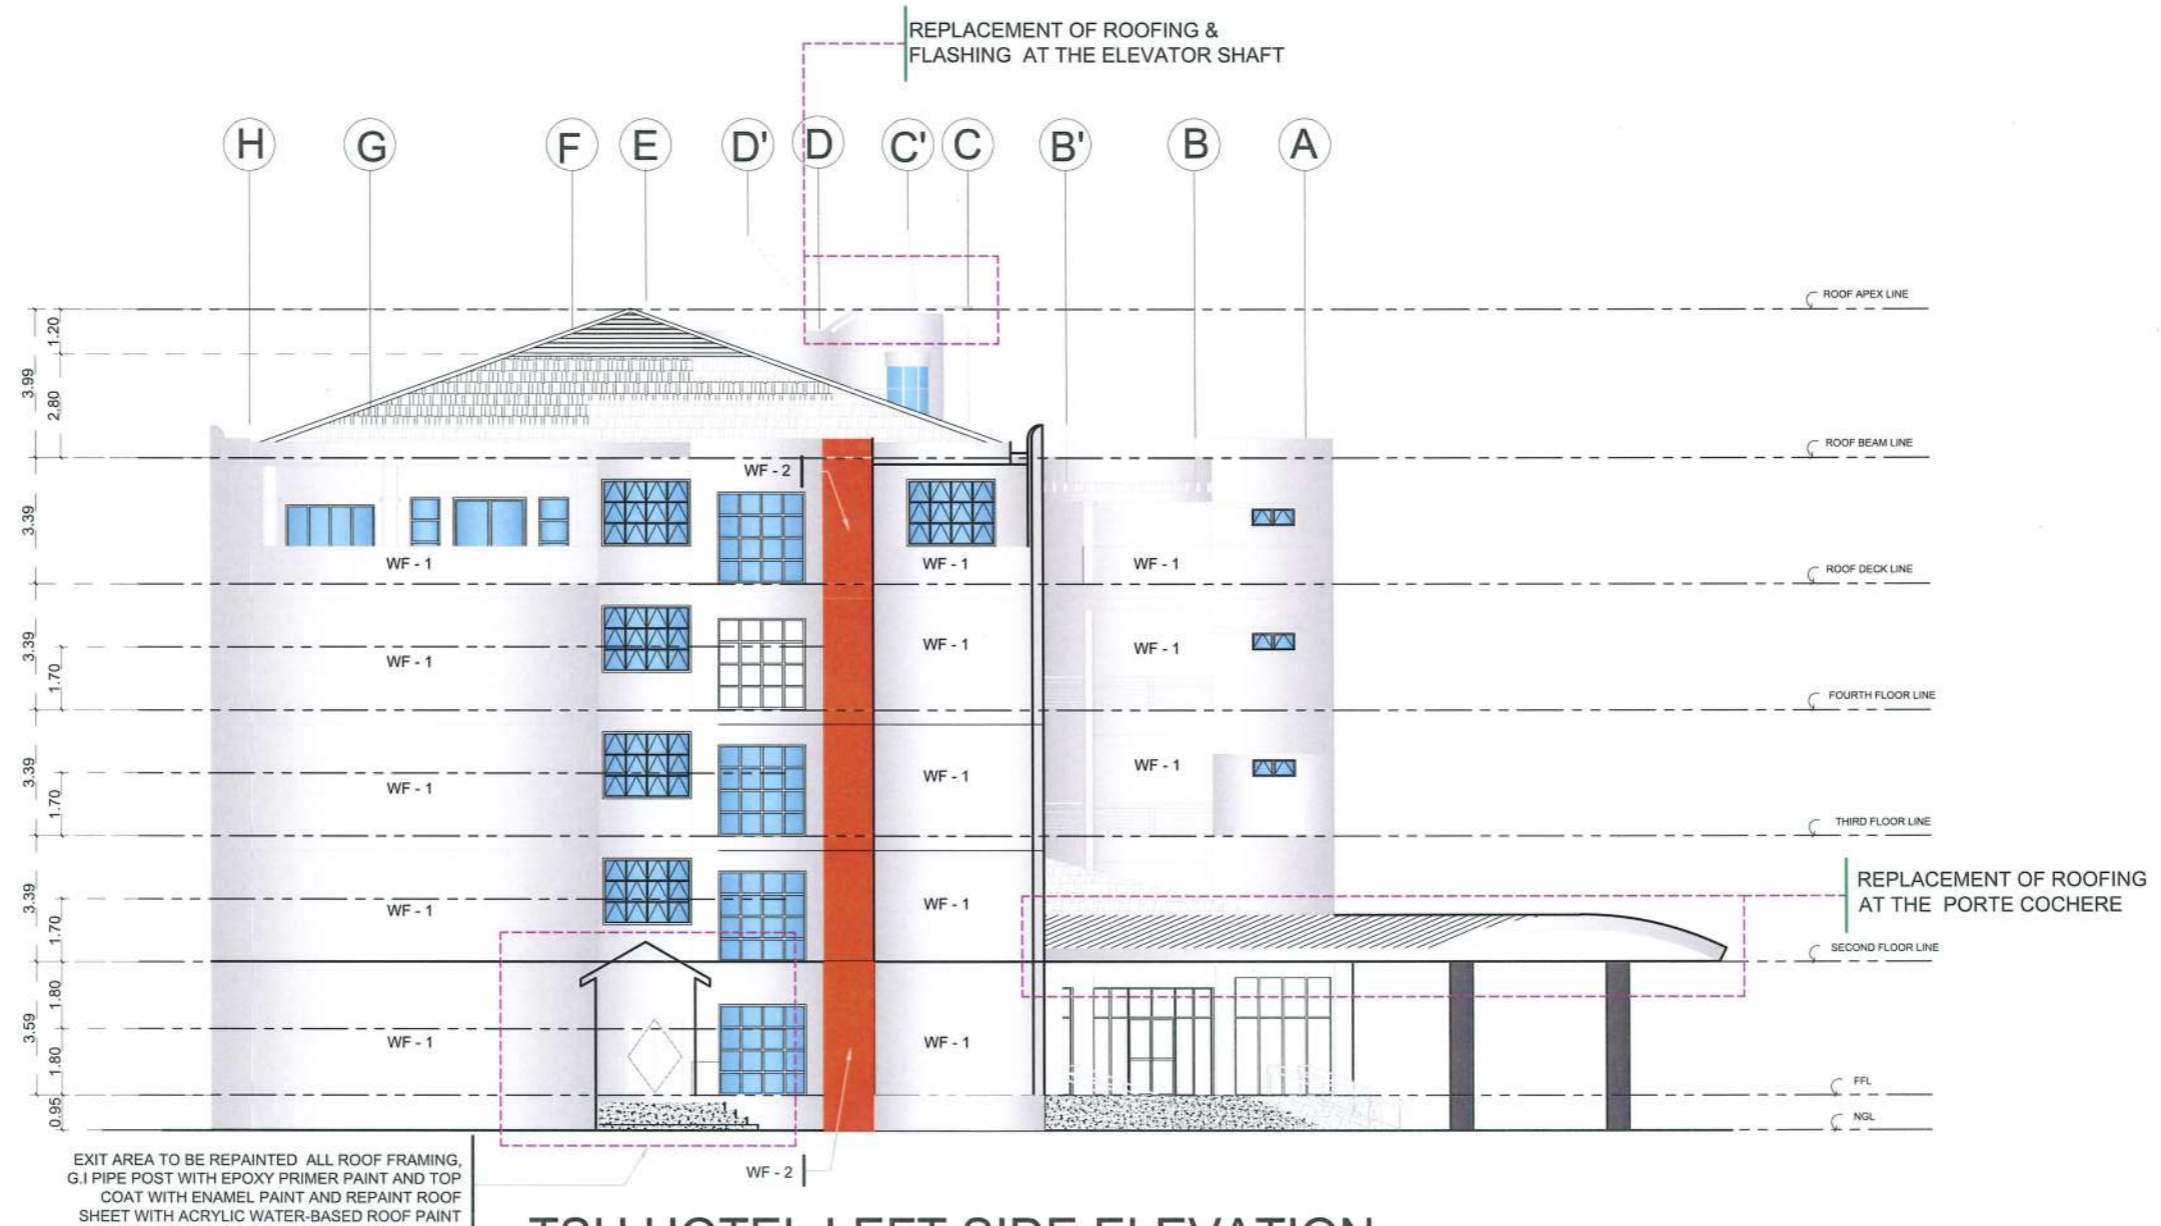
**TSU HOTEL LEFT SIDE ELEVATION**

1. SURFACE PREPARATION IS A MUST.
2. REPAIR & RE-PAINTING OF ALL WINDOW FRAMES USING ENAMEL PAINT (INTERIOR & EXTERIOR SIDE).
3. REPAIR & RE-PAINTING OF ALL AIR-CONDITION UNIT FRAMING USING ENAMEL PAINT.
4. APPLICATION OF SKIMCOAT/ BODY FILLER PRIOR TO TOPPING OF PRIMER AND TOPCOATS OF PAINT.
5. TYPE OF PAINT TO BE USED MUST BE APPROVED BY THE PROJECT IN-CHARGE.

SURFACE PREPARATION, APPLICATION OF SANDED GROUT AND TOP WITH ACRYLIC EMULSION
