EXISTING TARLAC STATE UNIVERSITY HOTEL PERSPECTIVE

PROJECT TITLE: REPAIR AND RE-PAINTING OF TSU HOTEL	REQUESTING OFFICE:  MR. VON REX M. REYES MANAGER, TSU HOTEL	PREPARED BY:  MR. WENCIE S. MANABOG DRAFTSMAN, FDMO	CERTIFIED BY:  AR. ARLEN M. GUIEB DIC DIRECTOR, FDMO	RECOMMENDING APPROVAL:  DR. GRACE N. ROSETE VP, ADMINISTRATION AND FINANCE	APPROVED:  DR. ARNOLD E. VELASCO PRESIDENT	SHEET CONTENTS: AS SHOWN DATE: NOVEMBER, 2023	SHEET NO.: A-2 PAGE NO.: 02/19
PROJECT LOCATION: LUCINDA EXTENSION CAMPUS, TARLAC STATE UNIVERSITY

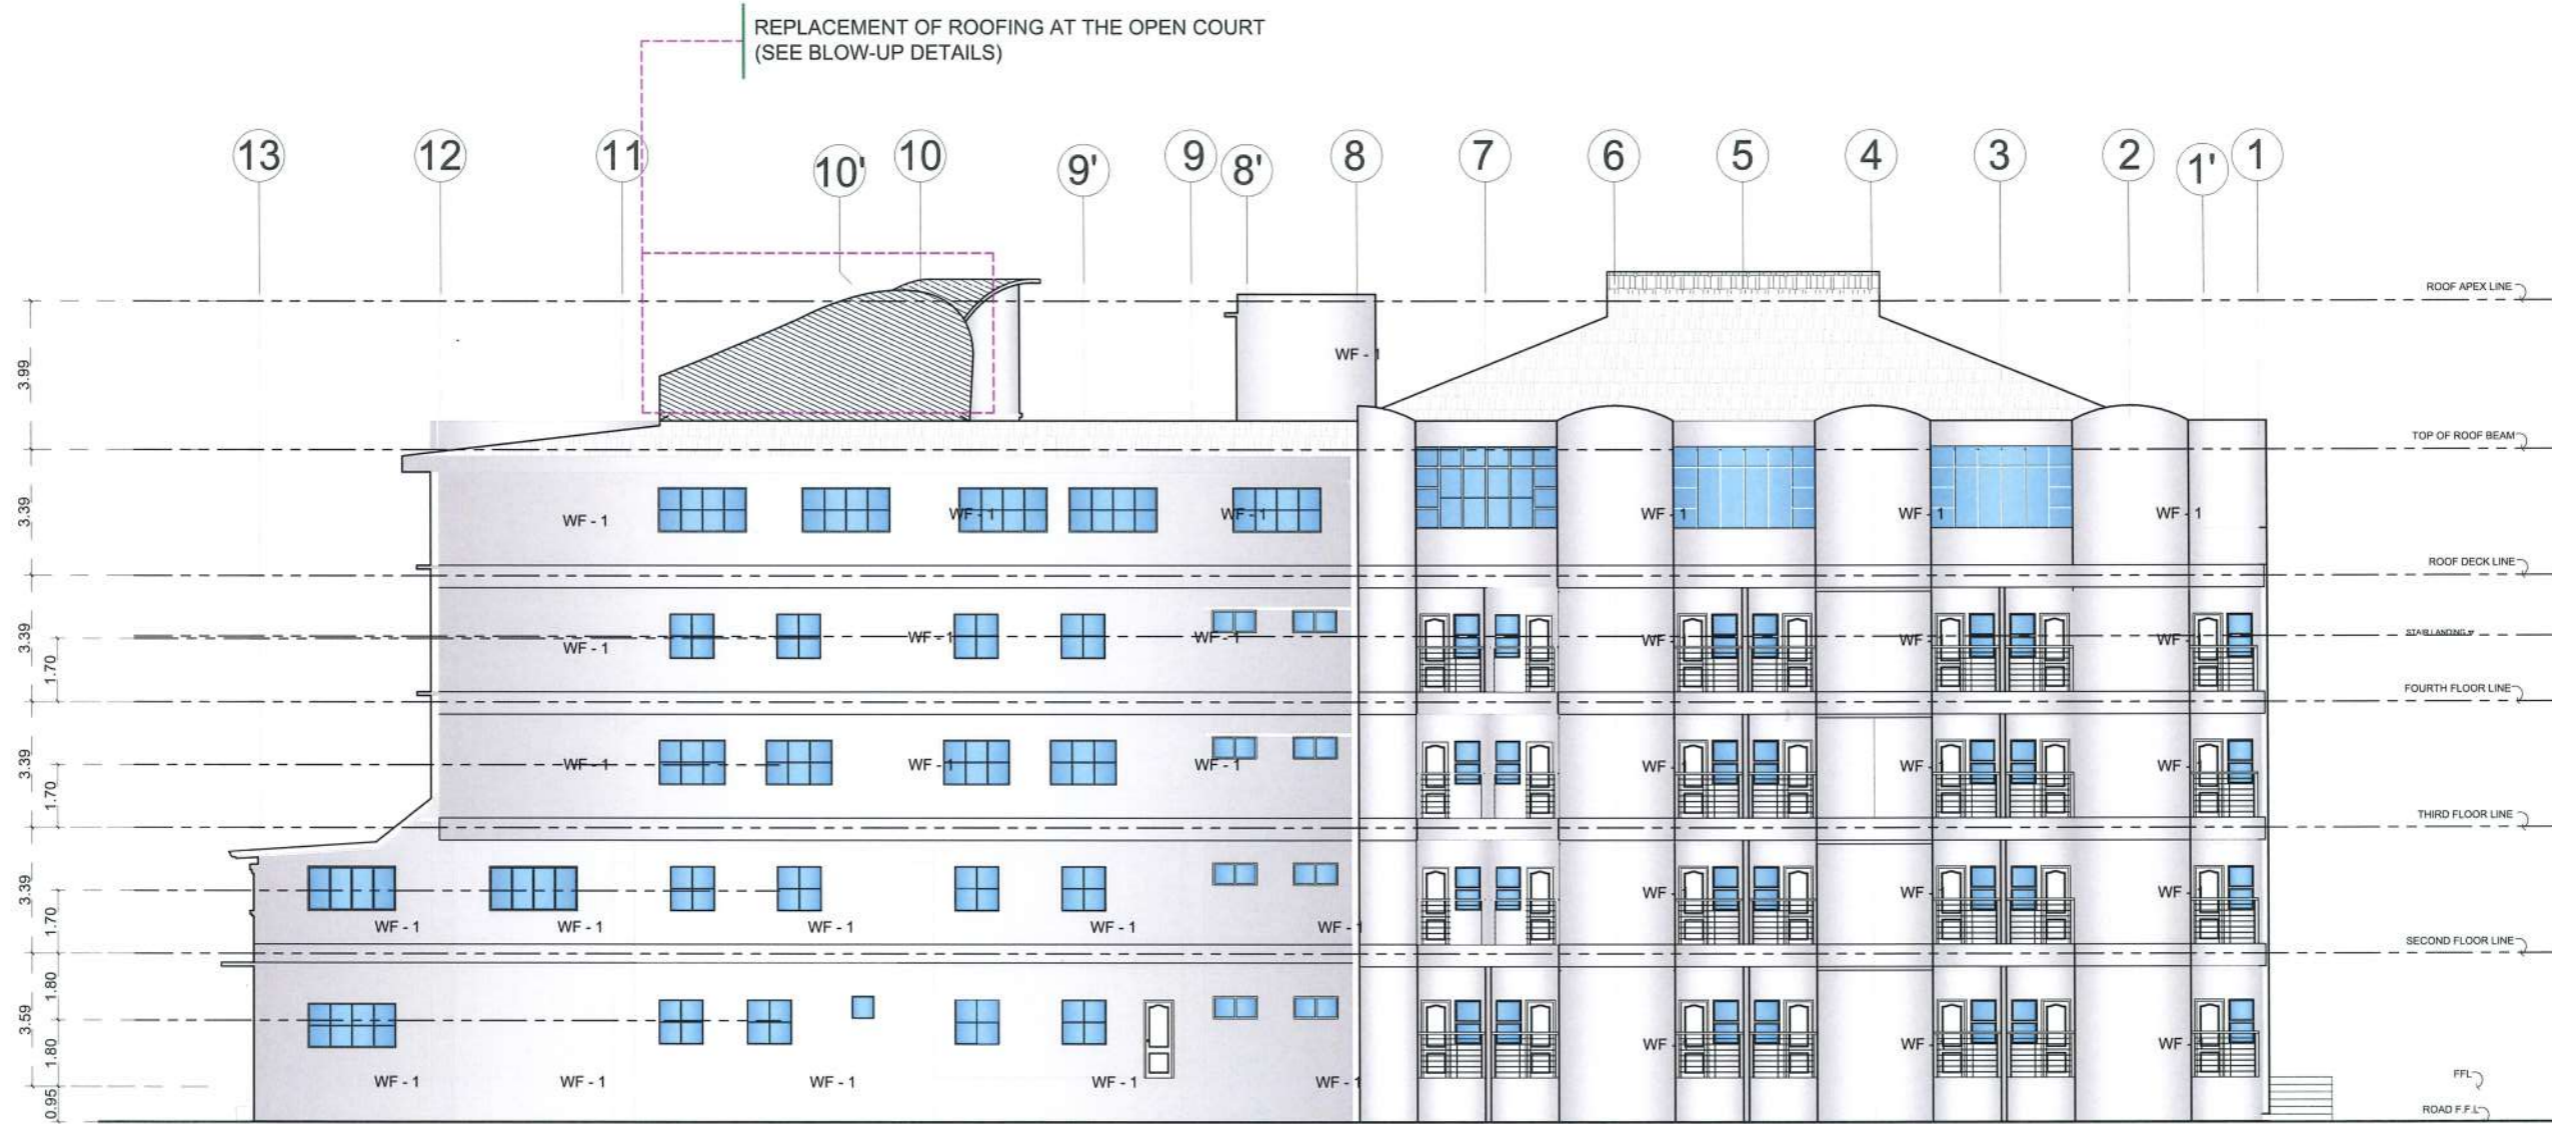
**TSU HOTEL REAR ELEVATION**

1. SURFACE PREPARATION IS A MUST.
2. REPAIR & RE-PAINTING OF ALL WINDOW FRAMES USING ENAMEL PAINT (INTERIOR & EXTERIOR SIDE).
3. REPAIR & RE-PAINTING OF ALL AIR-CONDITION UNIT FRAMING USING ENAMEL PAINT.
4. APPLICATION OF SKIMCOAT/ BODY FILLER PRIOR TO TOPPING OF PRIMER AND TOPCOATS OF PAINT.
5. TYPE OF PAINT TO BE USED MUST BE APPROVED BY THE PROJECT IN-CHARGE.

SURFACE PREPARATION, APPLICATION OF SANDED GROUT AND TOP WITH ACRYLIC EMULSION

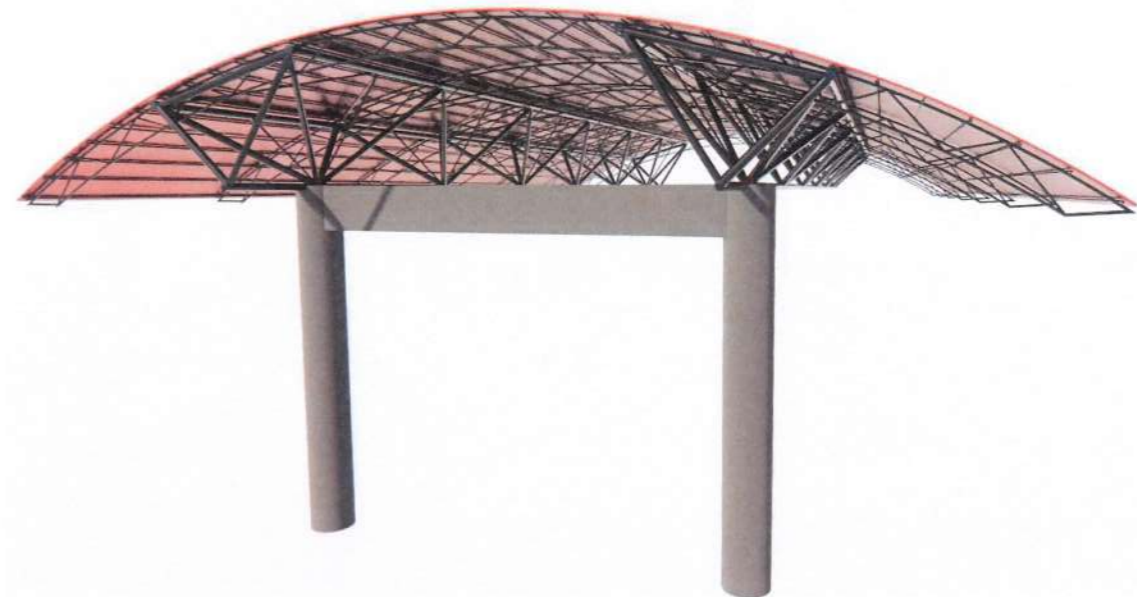
**PORTE COCHERE TRUSSES**

REPLACEMENT OF G.I PRE-PAINTED CURVED ROOF, AND REPAINTING OF EXISTING ROOF TRUSS

NOTE: SCRAPE EXISTING ROOF TRUSS PAINT PRIOR TO APPLICATION OF PRIMER AND TOP COATS.

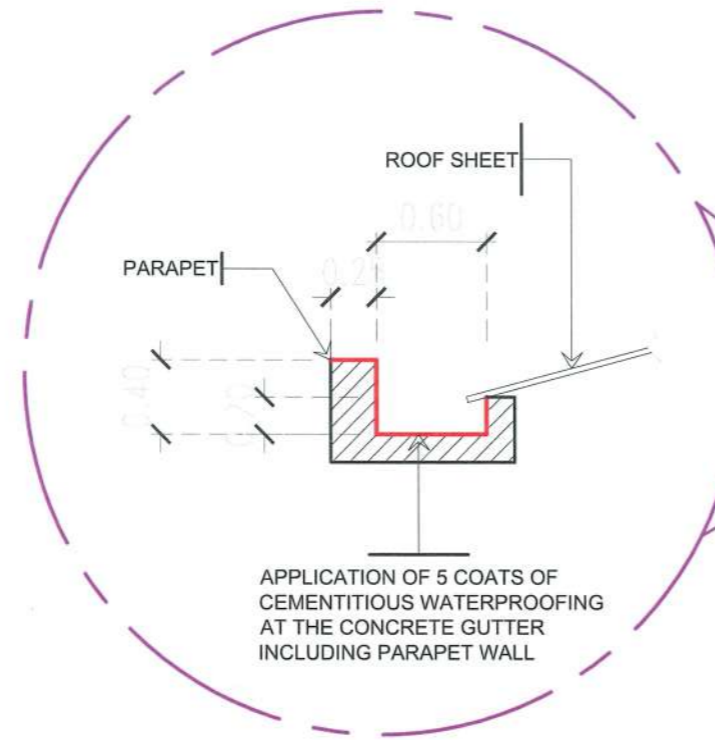
### CONCRETE GUTTER DETAILS

WATERPROOFING OF CONCRETE GUTTER AND PARAPET WALL

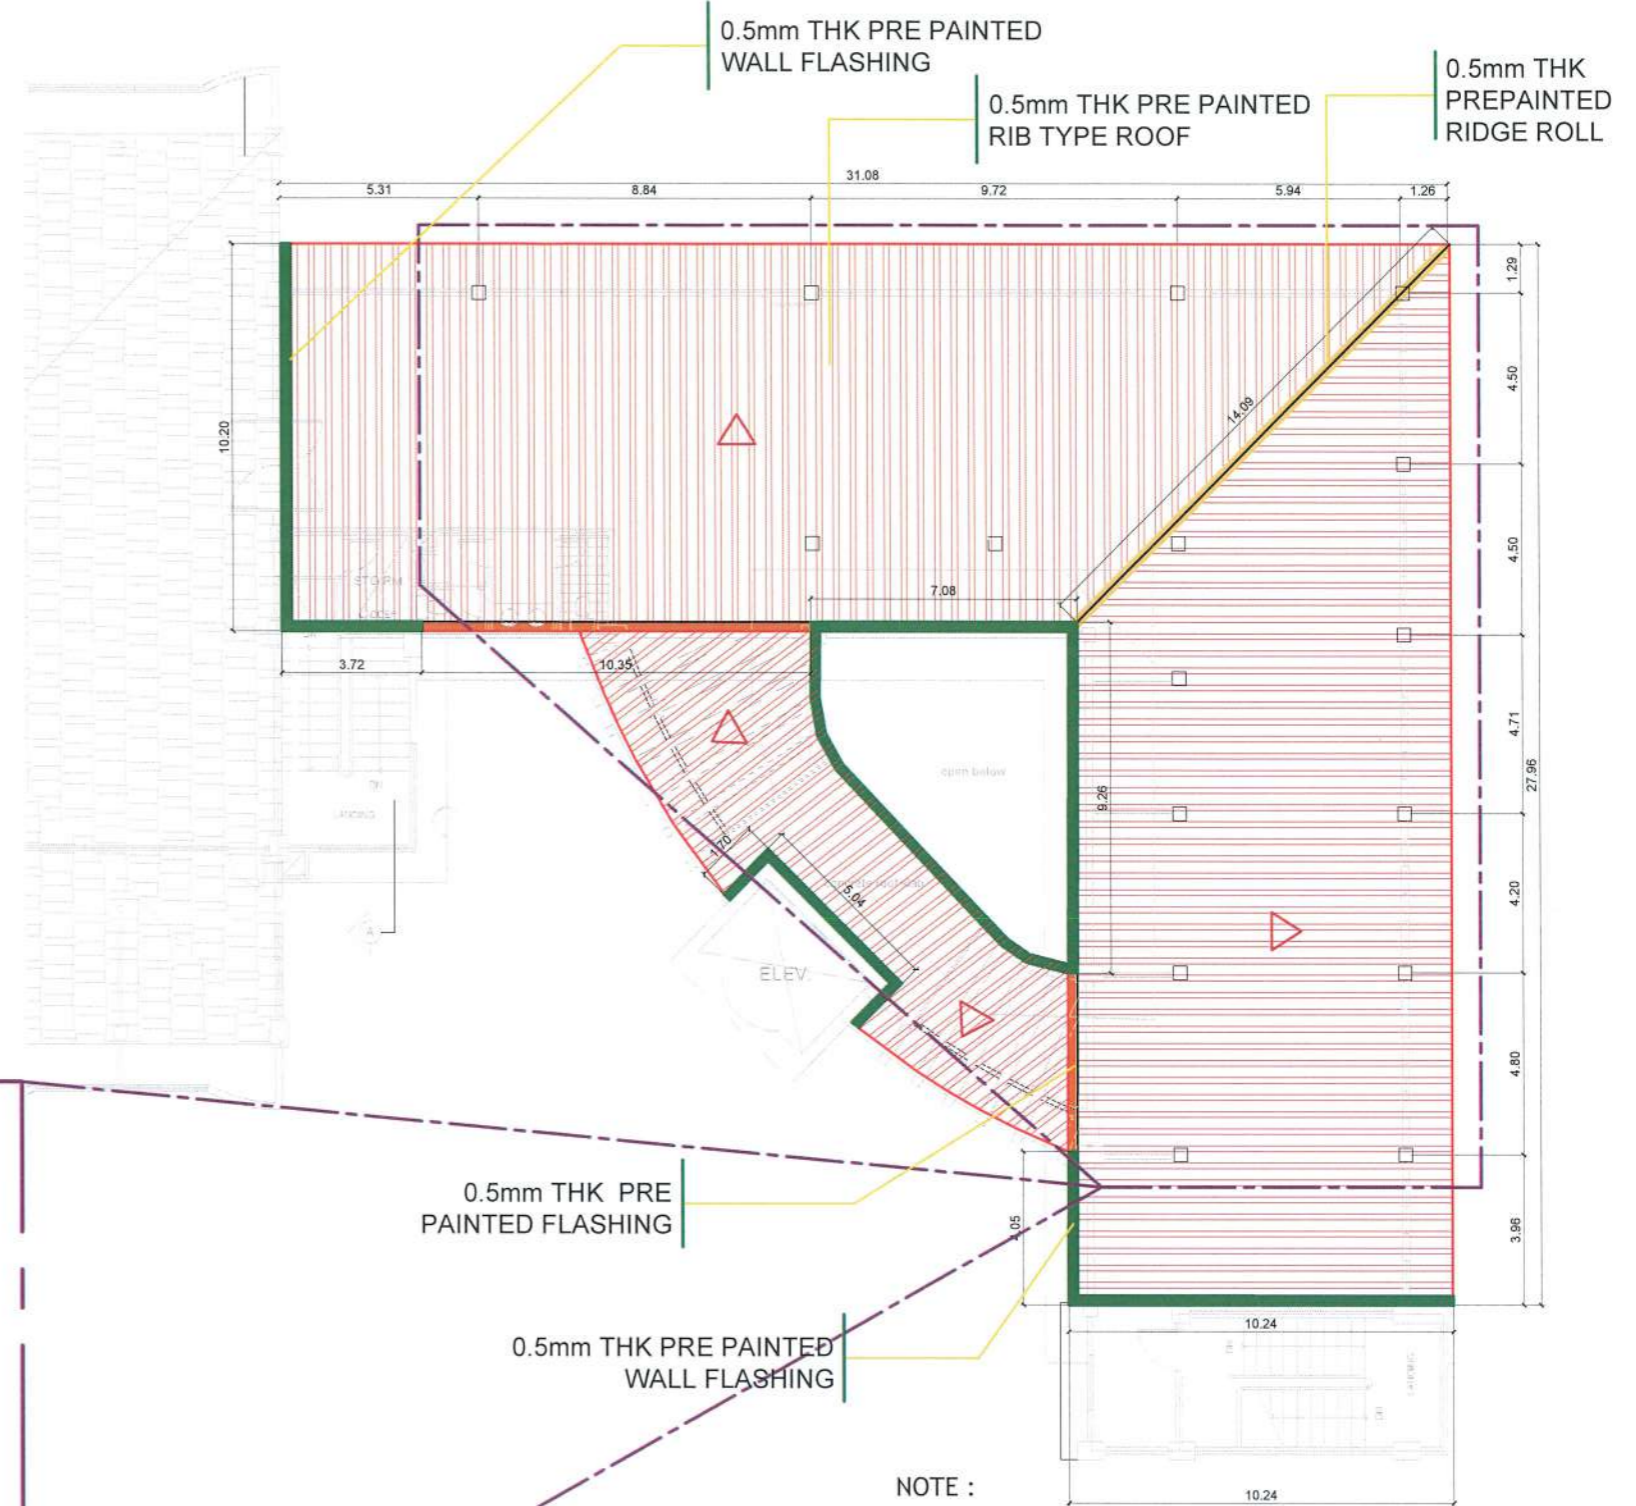
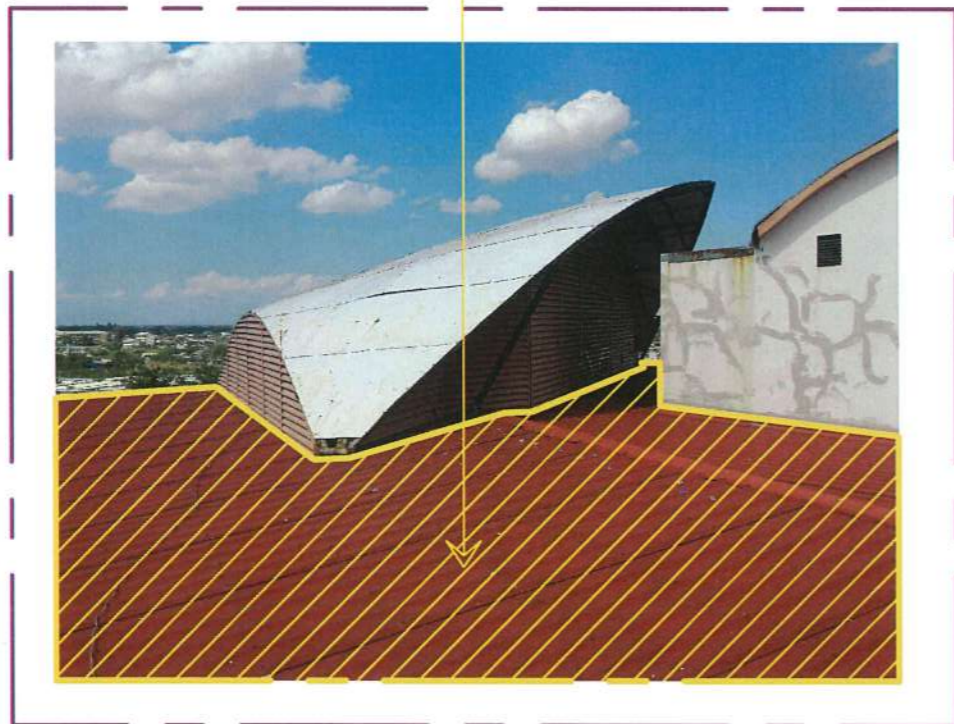
**PROPOSED REPLACEMENT OF ROOFING AT FIFTH FLOOR**

0.5mm THK PRE PAINTED RIB-TYPE ROOF

SUPPLY AND INSTALLATION OF 0.5mm THK LONG SPAN PRE-PAINTED RIB TYPE ROOFING

1. DRAWING DIMENSIONS PRIOR TO FABRICATION AND INSTALLATION ARE ALL APPROXIMATE , VERIFY ACTUAL MEASUREMENT ON SITE.
2. FULL TEKSCREW ON ROOF, SPACING @ EVERY RIB.

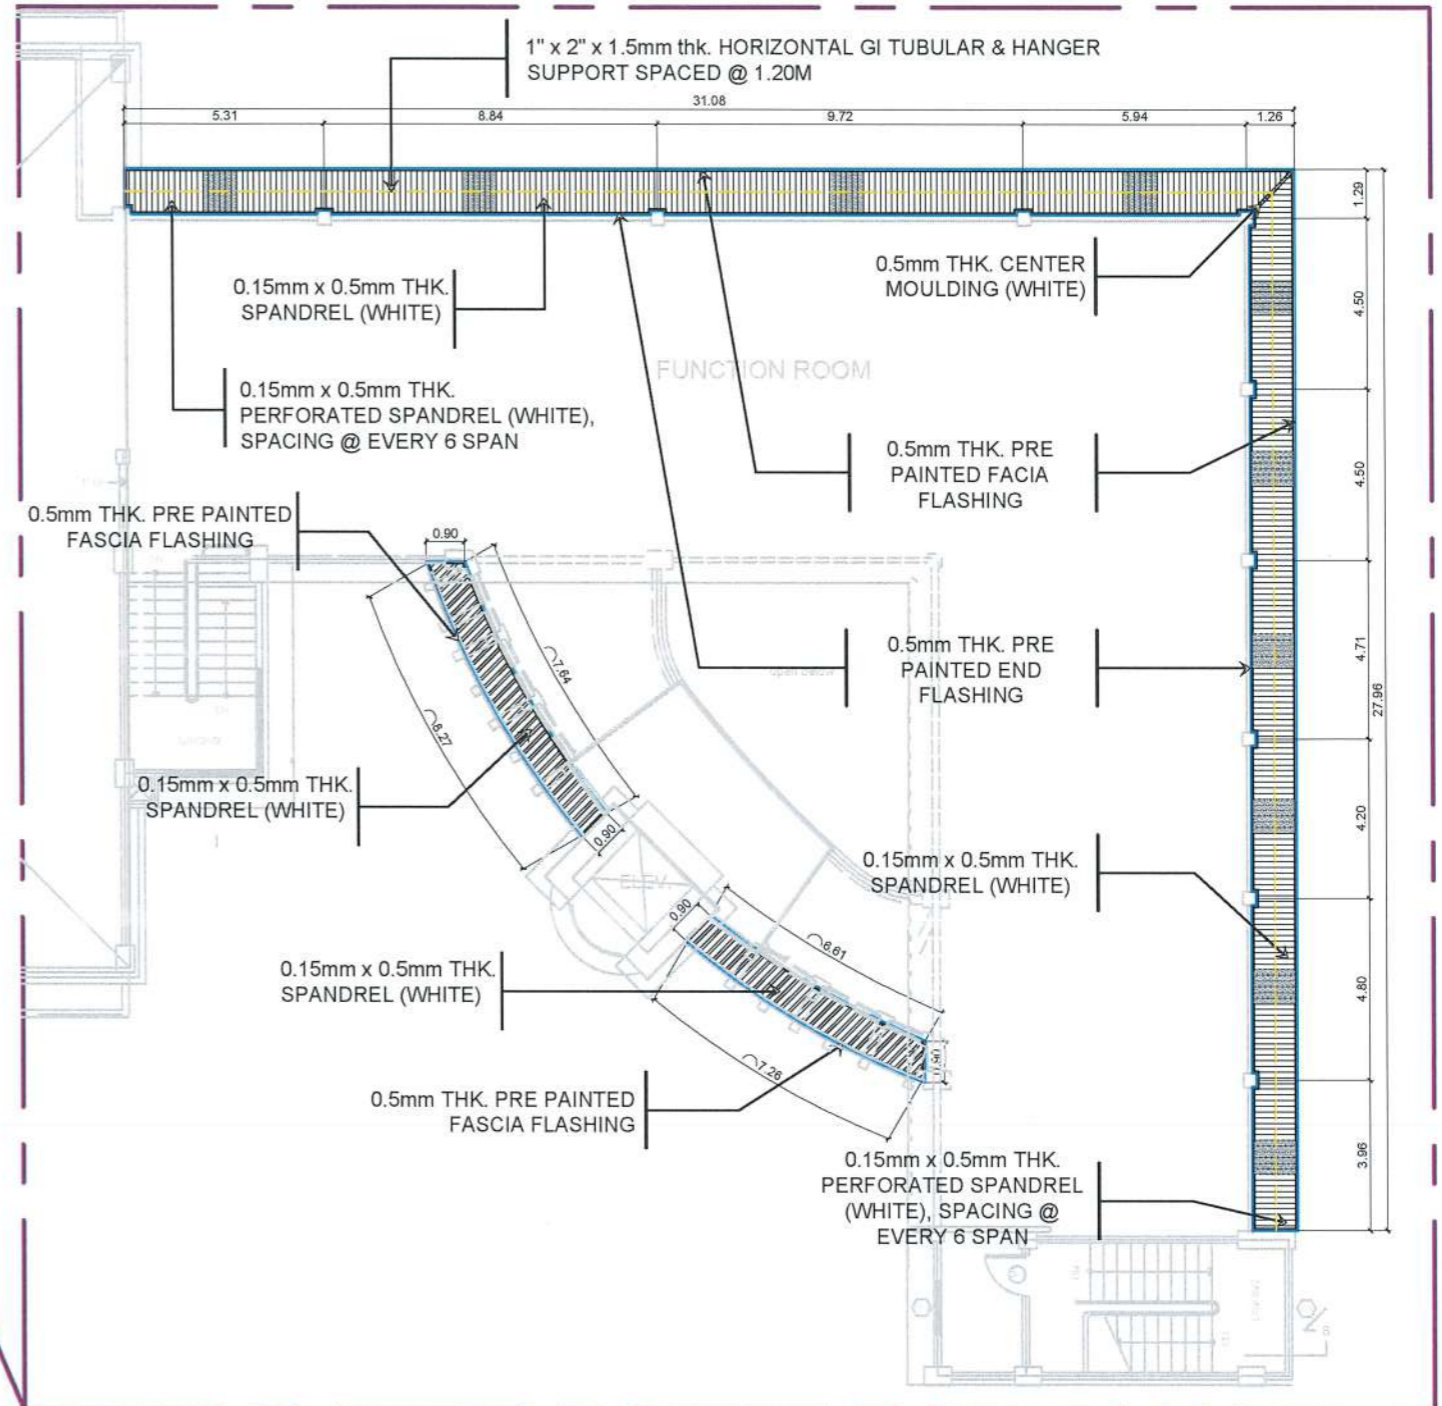
**PROPOSED ROOF EAVES AT FIFTH FLOOR**

-   DISMANTLING AND HAULING OF EXISTING ROOF EAVES
-   0.5MM THK. PERFORATED SPANDREL
-   1" x 2" x 1.5mm thk. HORIZONTAL GI TUBULAR & HANGER SUPPORT SPACED @ 1.20M

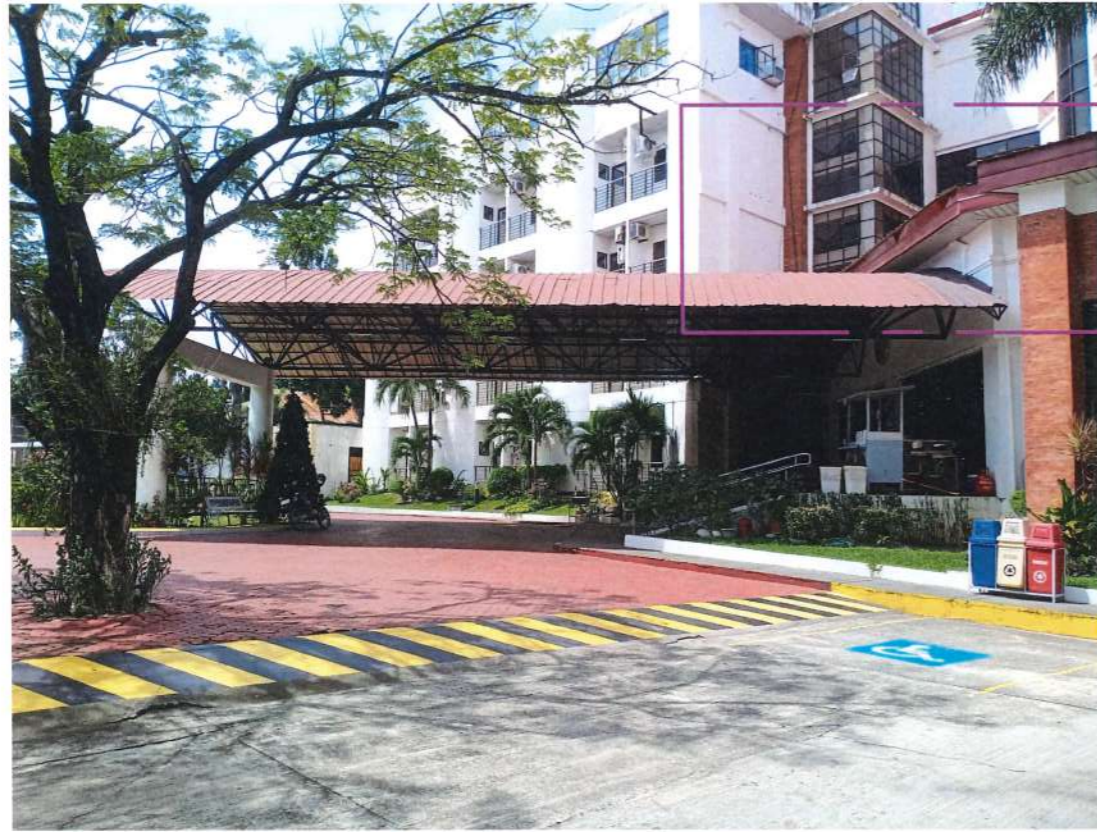
**EXISTING CONDITION OF FASCIA FLASHING**

REPAIR AND REPLACEMENT OF DAMAGED 0.5mm THK PRE-PAINTED FASCIA FLASHING (SEE FASCIA FLASHING DETAILS)

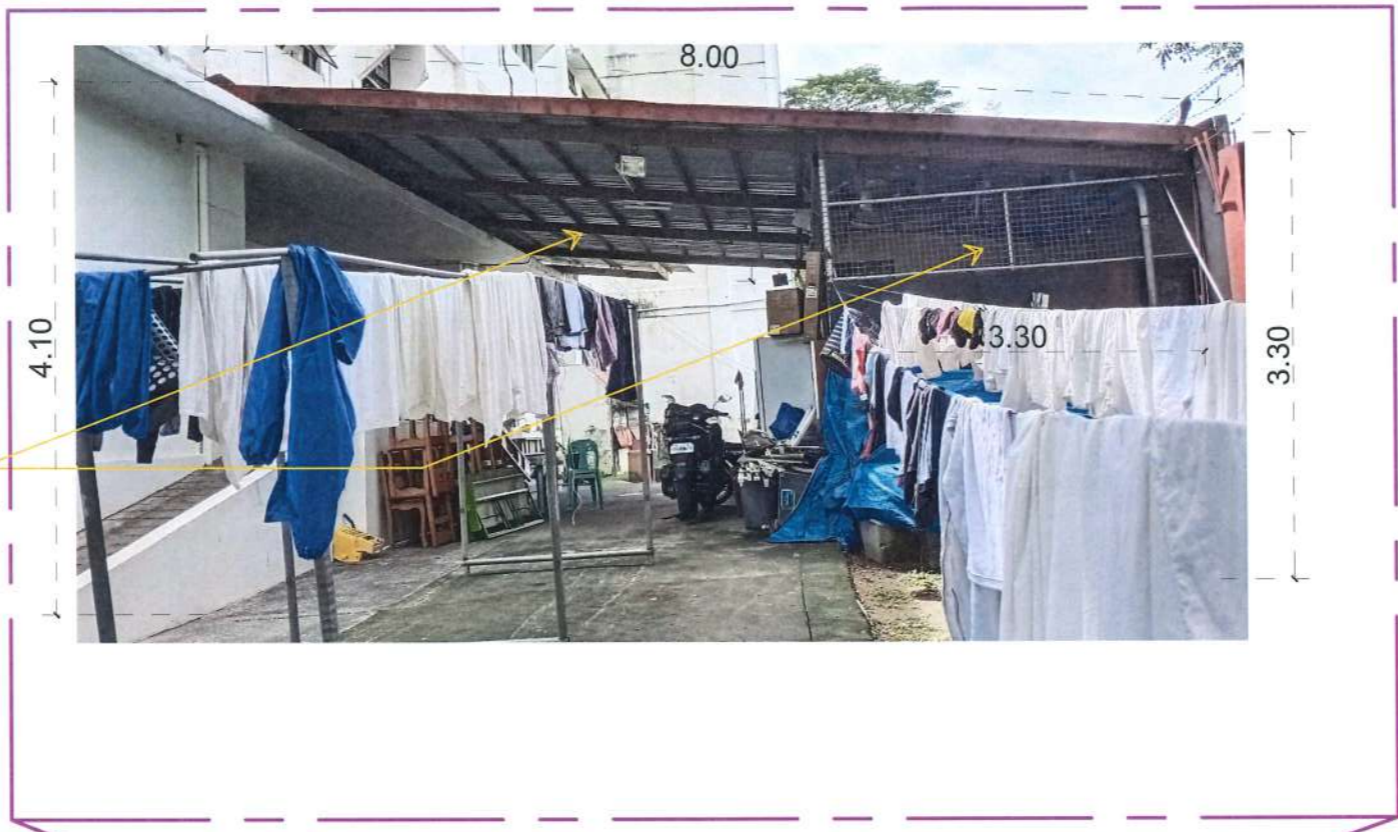
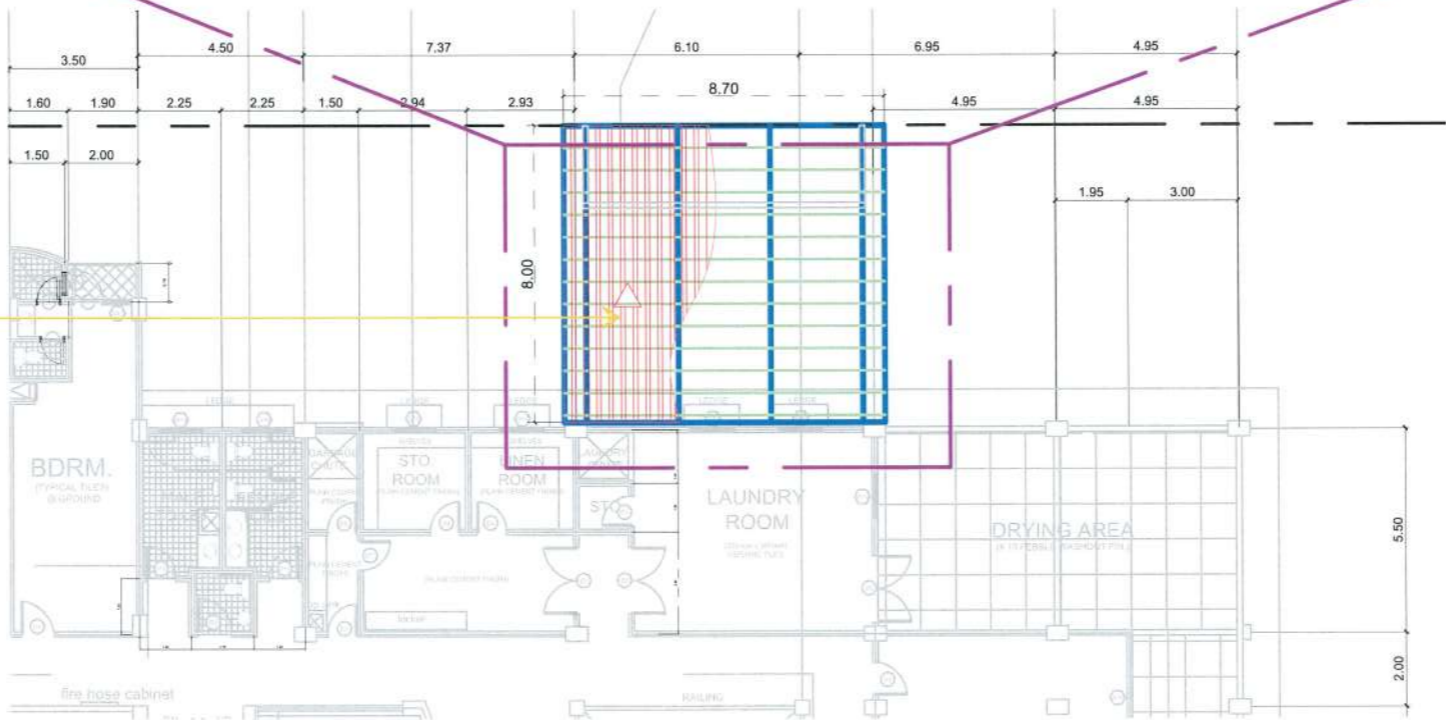
### SERVICE AREA ROOF PLAN

SERVICE AREA TO BE REPAINTED ALL ROOF FRAMING, G.I PIPE POST, STEEL MATTING PARTITIONS WITH EPOXY PRIMER PAINT AND REPAINT ROOF SHEET WITH ACRYLIC WATER-BASED ROOF PAINT INCLUDING SEMI-GLOSS LATEX PAINT ON AFFECTED PERIMETER FENCE AREA
